Briefing: Burst rising main incident

11 July 2025

Burst on our rising main reported

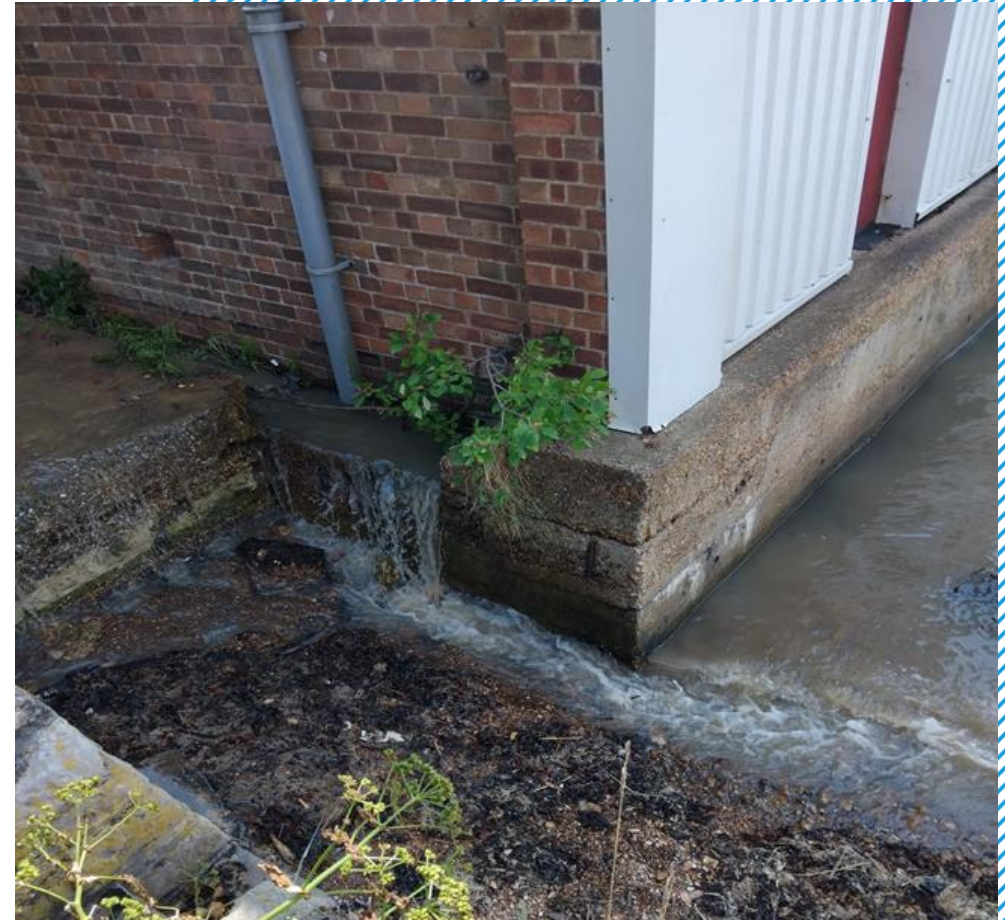
- Following a report of pollution from a member of the public, our contractor (Lanes) attended
- Burst was located on our 450mm glass reinforced plastic rising main, which conveys flows from School Lane Hamble WPS to Hook Park WPS, and eventually the receiving Peel Common WTW
- Flows noted to be running overland, over the footpath and entering the tidal river Hamble
- Majority of flows were entering the river next to Stone Pier Yard. Some flows also entered the rear garden of a domestic property and the nearby Saltmarsh
