Site Asbestos Register 11/01/2023

| Site/Building No/Unit Reference | Site Name , Main Building - 001X / 10501993 |
| Room Title & No | RESOURCES (090) |

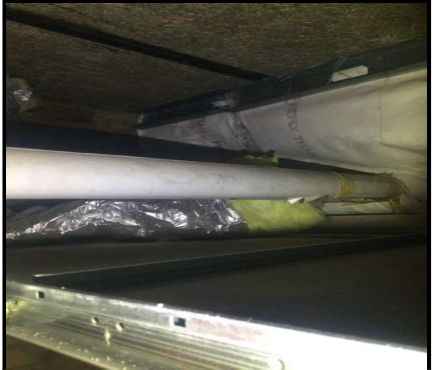
| Item No | 711534 | |

| Item No | Position | Add. Information | Material | Asbestos Presumed - Action | Photo Ref |
|---|---|---|---|---|---|
| 711534 | Above Ceiling | Beneath insulation to pipework | Asbestos Not Detected | NO - ITEM CAN BE DISTURBED | 2647911.jpg |

| Position Desc | Beneath insulation to pipework | |
| Asbestos Content | Not Asbestos | |

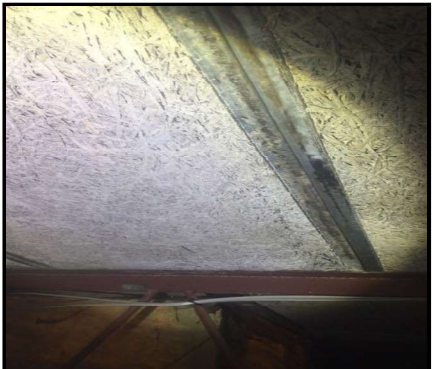
| Item No | 711533 | |

| Item No | Position | Add. Information | Material | Asbestos Presumed - Action | Photo Ref |
|---|---|---|---|---|---|
| 711533 | Above Ceiling | Residues to roof deck | Bitumen Product | NO - ITEM CAN BE DISTURBED | 2647931.jpg |

| Position Desc | Residues to roof deck | |
| Asbestos Content | Not Asbestos | |

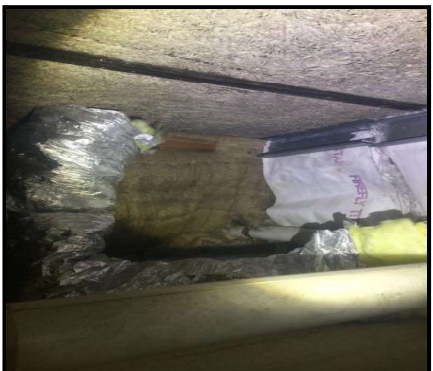
| Item No | 2647945 | |

| Item No | Position | Add. Information | Material | Asbestos Presumed - Action | Photo Ref |
|---|---|---|---|---|---|
| 2647945 | Above Ceiling | Firebreak | Asbestos Not Detected | NO - ITEM CAN BE DISTURBED | 2647945.jpg |

| Position Desc | Firebreak | |
| Asbestos Content | Not Asbestos | |

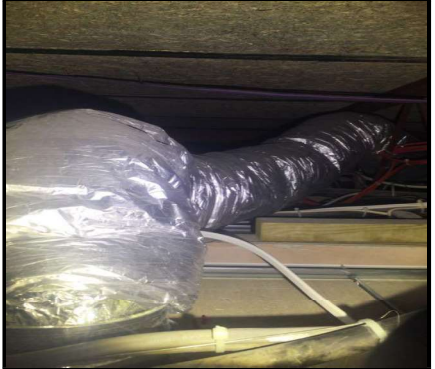
| Item No | 2647954 | |

| Item No | Position | Add. Information | Material | Asbestos Presumed - Action | Photo Ref |
|---|---|---|---|---|---|
| 2647954 | Above Ceiling | Extractor ducting | Asbestos Not Detected | NO - ITEM CAN BE DISTURBED | 2647954.jpg |

| Position Desc | Extractor ducting | |
| Asbestos Content | Not Asbestos | |

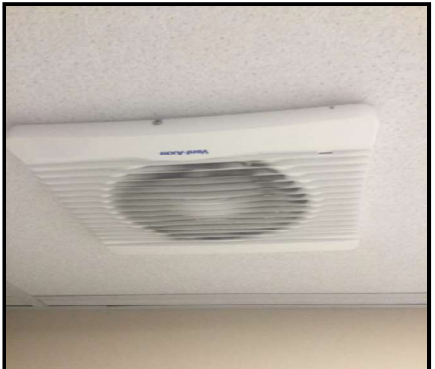
| Item No | 2647953 | |

| Item No | Position | Add. Information | Material | Asbestos Presumed - Action | Photo Ref |
|---|---|---|---|---|---|
| 2647953 | Extractor | Ceiling mounted | Asbestos Not Detected | NO - ITEM CAN BE DISTURBED | 2647953.jpg |

| Position Desc | Ceiling mounted | |
| Asbestos Content | Not Asbestos | |

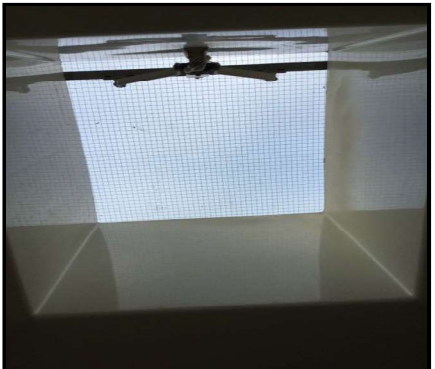
| Item No | 900212 | |

| Item No | Position | Add. Information | Material | Asbestos Presumed - Action | Photo Ref |
|---|---|---|---|---|---|
| 900212 | Skylights | Sealant to wired glazing | Putty | YES - ASBESTOS DO NOT DISTURB | 2647921.jpg |

| Position Desc | Sealant to wired glazing | |
| Asbestos Content | Asbestos - Do Not Disturb | |

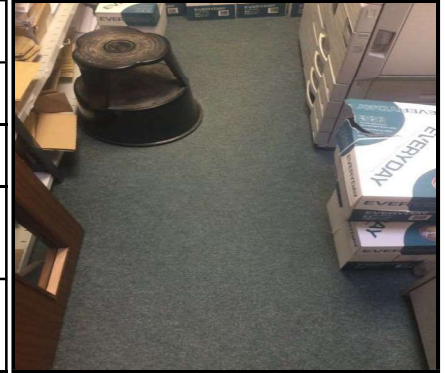
| Item No | 711535 |

| Item No | Position | Add. Information | Material | Asbestos Presumed - Action | Photo Ref |
|---|---|---|---|---|---|
| 711535 | Under Carpet/Lino | | Asbestos Not Detected | NO - ITEM CAN BE DISTURBED | 2647938.jpg |

| Position | Under Carpet/Lino |
| Asbestos Content | Not Asbestos |
