HAMPSHIRE COUNTY COUNCIL**Report**

Committee	River Hamble Harbour Management Committee
Date:	14 March 2014
Title:	Harbour Master's Report
Reference	5647
Report From:	Director of Culture, Communities and Business Services

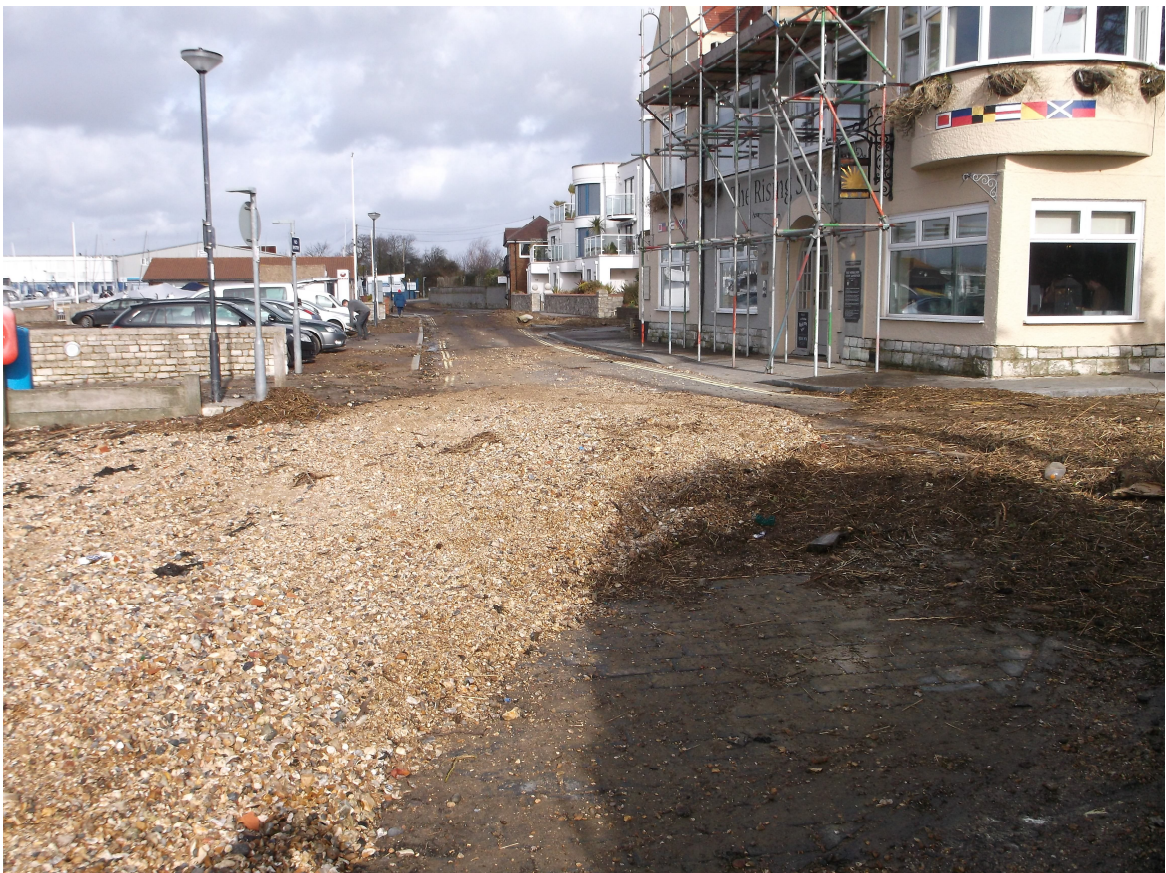
- 3.7 6 Feb. Patrol towed the vessels involved in the catamaran incident the day before. Moderate damage had been sustained by all vessels involved, and one had been dismantled.
- 3.8 7 Feb. Patrol replaced broken stern line on vessel.
- 3.9 15 Feb. Following an exceptionally windy night, with gusts up to 70 knots and a 1.2 metre tidal surge, the Patrol spent most of the day dealing with incidents on the River. These included: broken berthing ropes, missing fenders, shredded sails and damaged pontoons. Many tonnes of gravel/shingle and other debris were pushed onto the upper part of Warsash slipway and deposited on the adjoining parts of Shore Road by the storm (see photo, showing the top of the slipway in the left foreground and the Rising Sun public House on the right, taken after an initial clear up of large items of debris had been carried out).
