**Langstone Harbour Board
Ferry Terminal Inspection
Phase 1**

Final Report

August 2010

Langstone Harbour Board

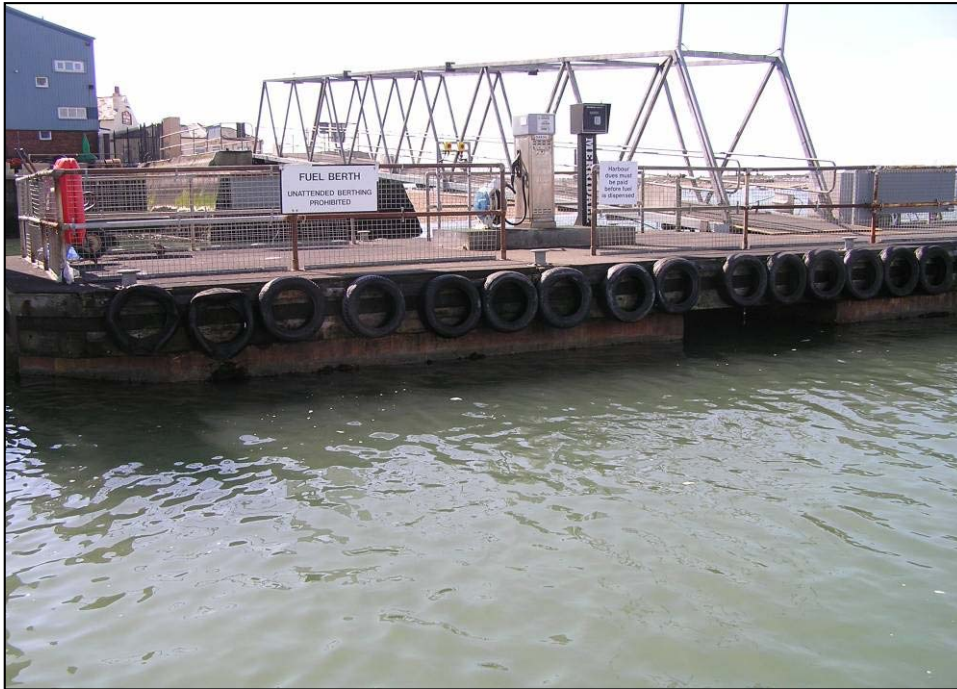
Figure 2.1 – Hayling pontoon and linkspan viewed from the north-east

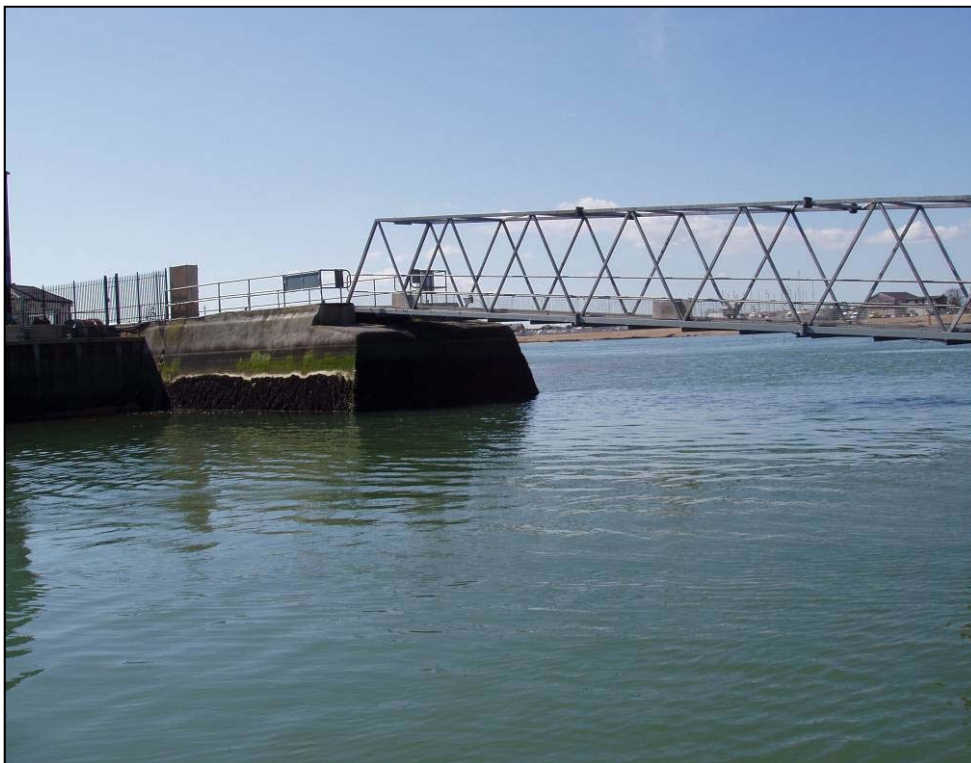
Figure 2.2 Hayling linkspan and fixed approach viewed from the east

The fixed approach is in fair condition and the only obvious work identified is to review the adequacy of the railing arrangement in terms of it providing adequate safe control of pedestrians, especially children – refer to Fig 2.2 (Hayling).

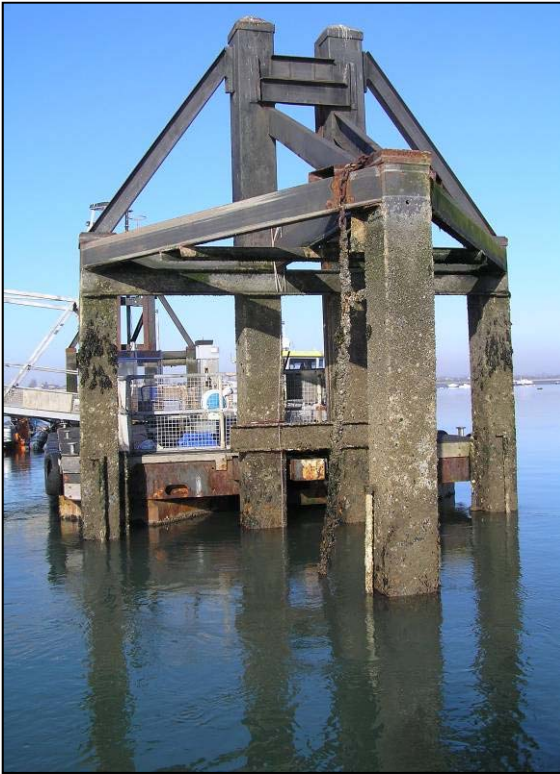
Figure 2.3 East dolphin of Hayling facility

Both dolphins appear to be in generally fair condition, despite significant corrosion. More detailed assessment is required to determine their condition. The dolphins appear to have been supplemented by the addition of several steel members to their superstructures.

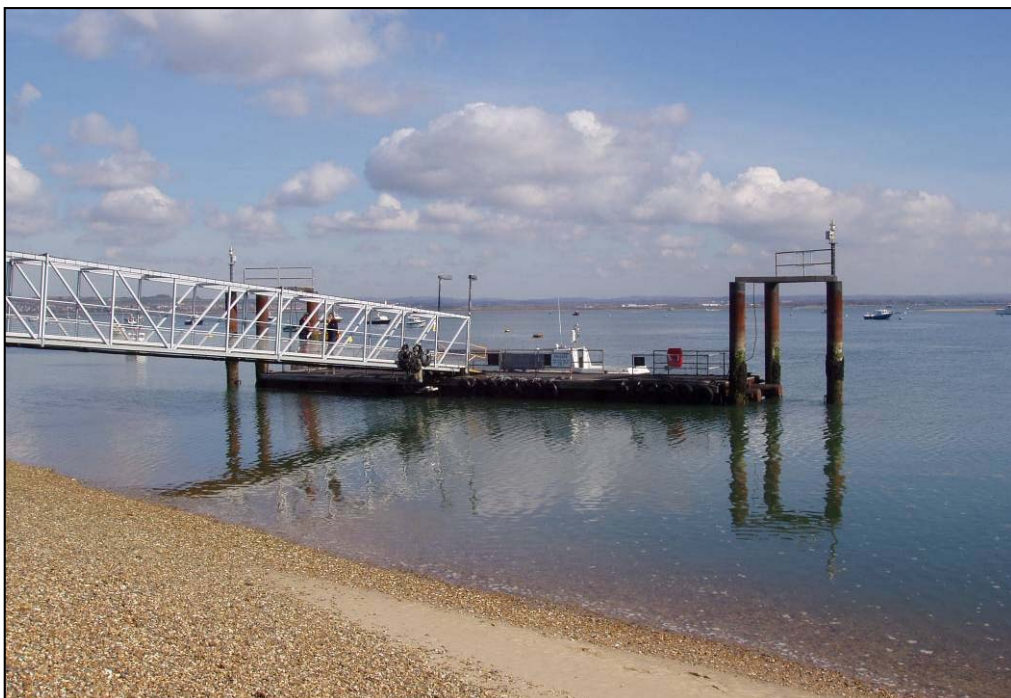
Figure 2.1 – Eastney linkspan, pontoon and dolphins viewed from the south

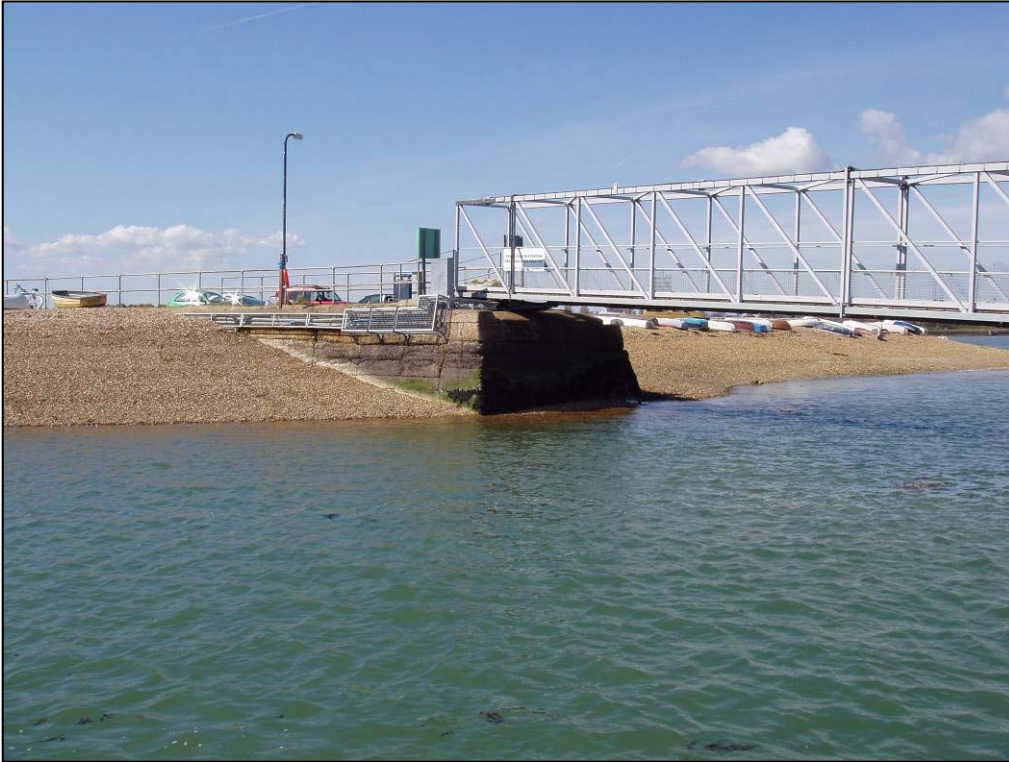
Figure 2.2 Eastney linkspan and fixed approach viewed from the east

The fixed approach is in fair condition and the only obvious work identified is to review the adequacy of the railing arrangement in terms of it providing adequate safe control of pedestrians, especially children – Refer to Figure 2.2 (Eastney).
