# Winchester Section 19 Investigation

## Final Report

June 2021

**Hampshire**  
County Council

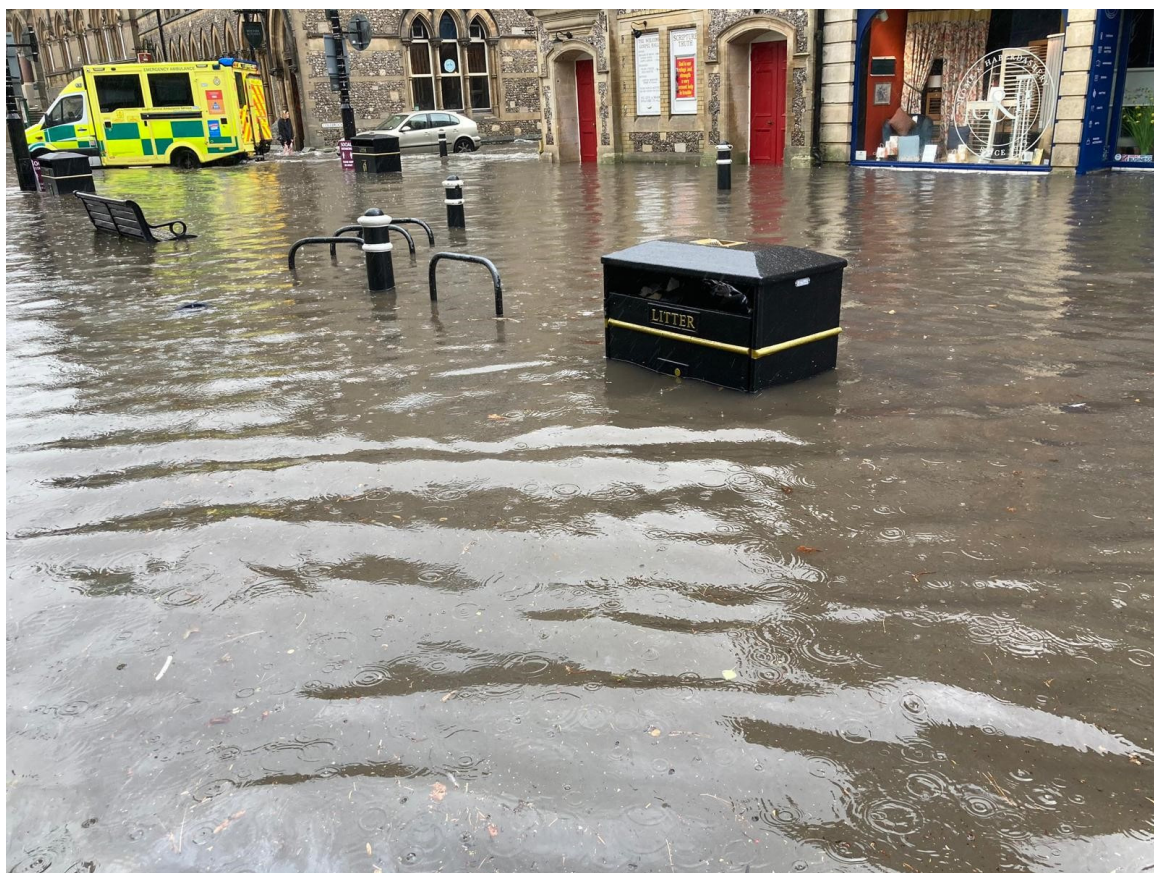
**Figure 1-1: Flooding to Winchester High Street on 27 August 2020<sup>5</sup>**

Surface water flooding was experienced across Winchester on 27 August 2020, affecting a number of areas including the High Street (Figure 1-1), Stockbridge Road, Cranworth Road, Andover Road and parts of Harestock. This flooding triggered HCC's criteria to undertake a Section 19 Investigation as over 20 residential properties were flooded internally across Winchester. The flooding caused internal flooding to a number of commercial properties in the High Street. The flooding also affected significant lengths of the public highway.

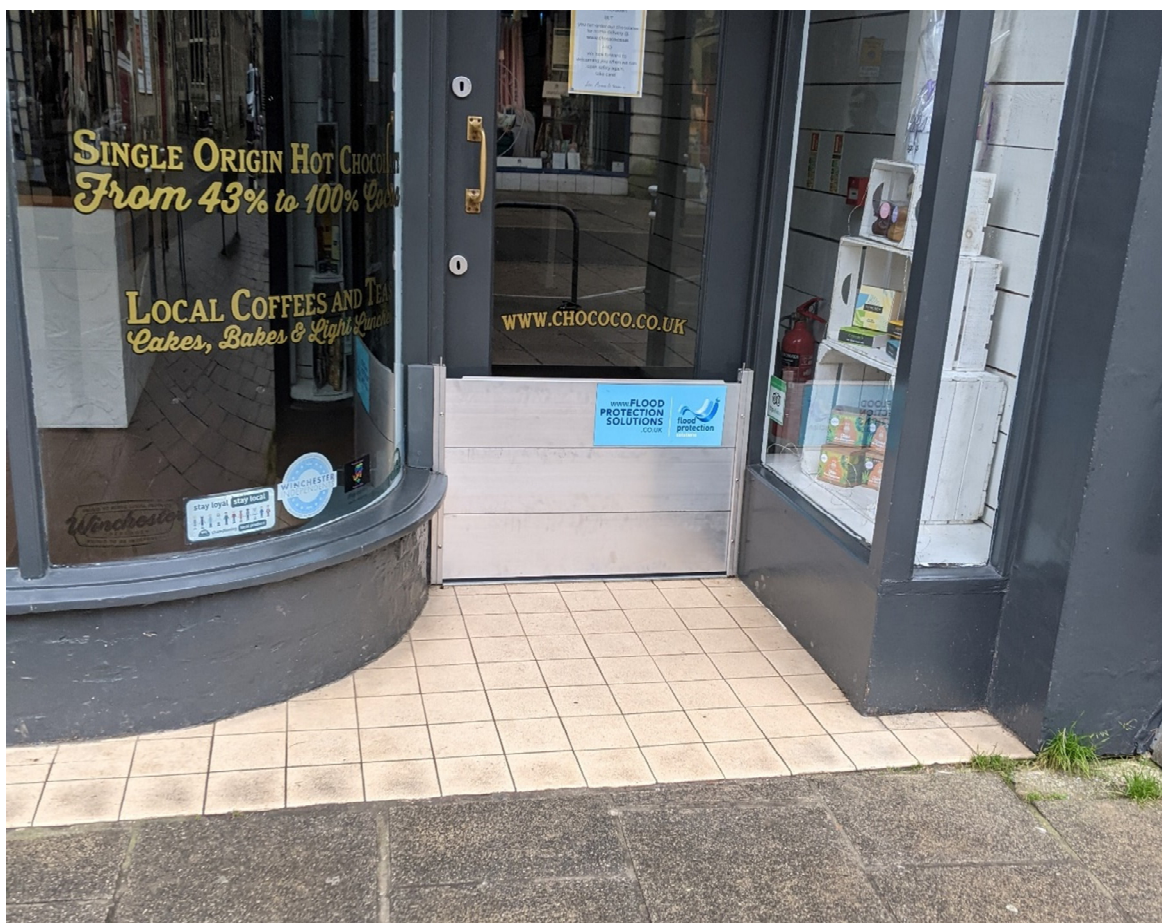
**Figure 5-3: Flood barrier installed on property in the High Street**

The site visit identified the low property thresholds in the High Street as being a particular issue, as these shops could flood even with relatively shallow external flood depths. It was also noted that a number of drains in the Broadway were blocked with silt, these could have exacerbated existing surface water flooding if they were blocked during the event. Although the site visit took place over four months after the event, a number of shops have sandbags in place in an attempt to prevent or mitigate flooding. One shop (Chococo) was noted to have installed flood barriers outside the main entrance.

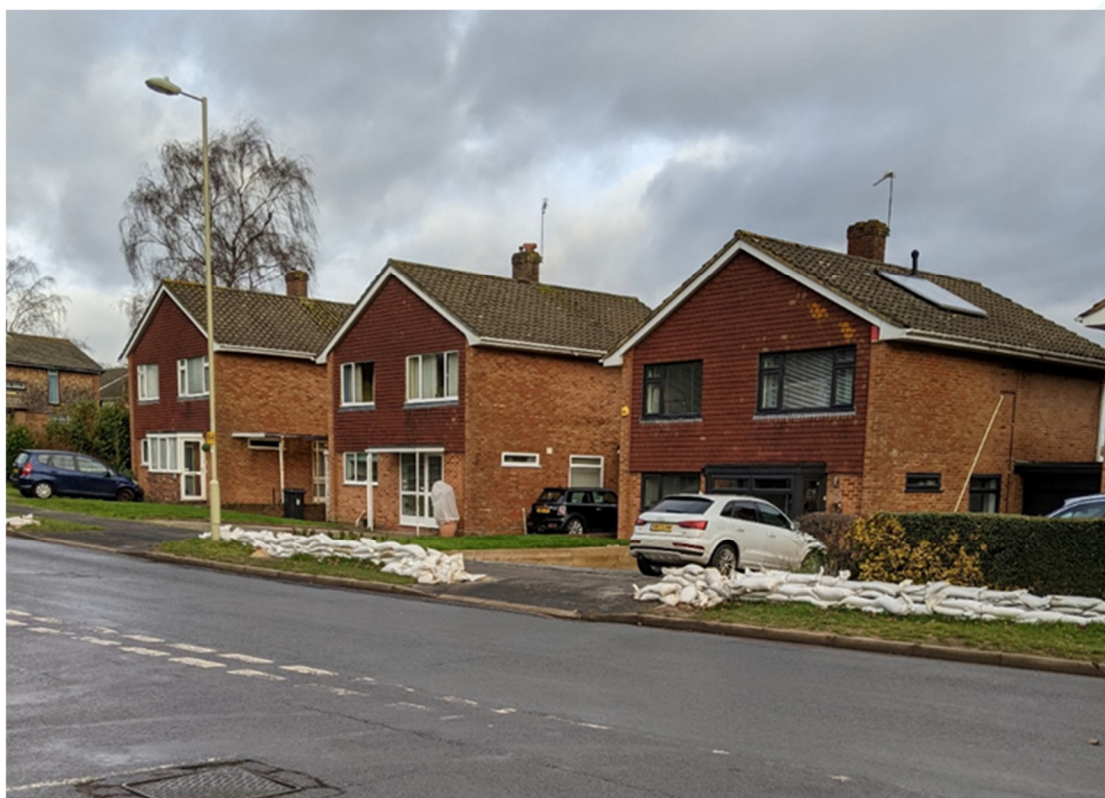
**Figure 5-4: Use of sandbags in Harestock**

A site walkover was conducted for a number of areas in Harestock including Priors Dean Road, Buriton Road, Grayshott Close and Bradley Road. These areas were visited to identify the causes and mechanisms of flooding, this was important as there was no available CCTV footage on the day of the event and photographic evidence was more limited. The walkover identified a number of blocked highway drains that may have contributed to or exacerbated flooding. The site walkover also identified that a number of properties along Buriton Road were using sandbags as a barrier to prevent flooding.

Kerb lines and pavements were not noted to be low, however many of the properties along Priors Dean Road and Buriton Road are at a lower elevation than the road, once surface water could overtop the kerb lines, it would follow the topography towards these properties.

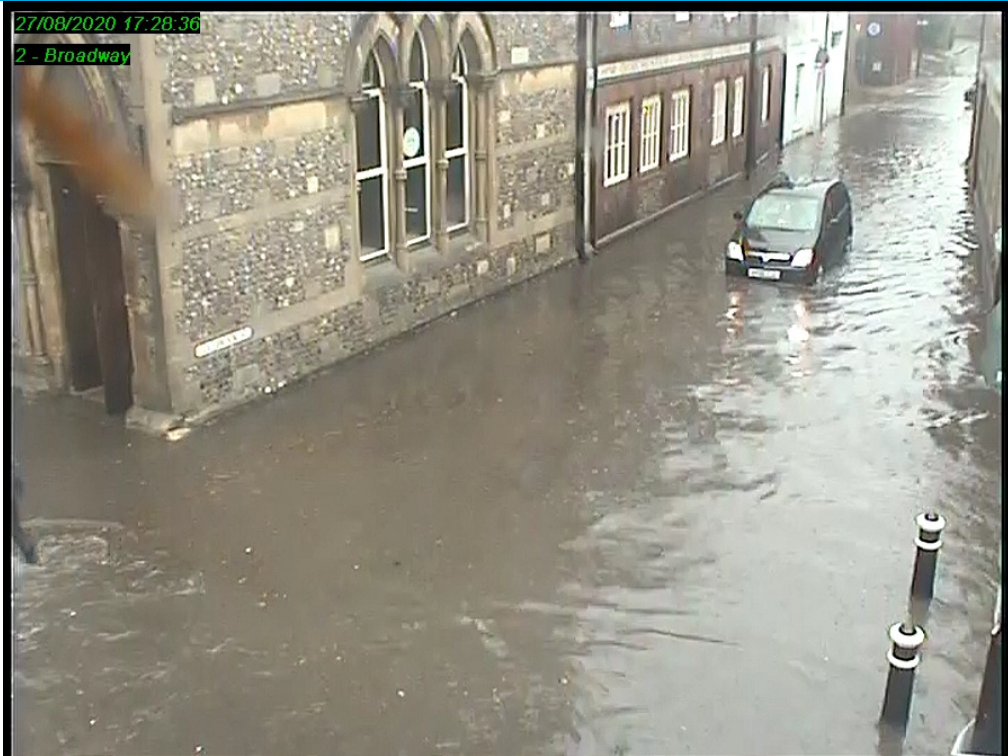
Figure 6-3: Photographs of the flooding in Winchester High Street on 27 August 2020

1. Surface water flooding along Colebrook Street (looking south)

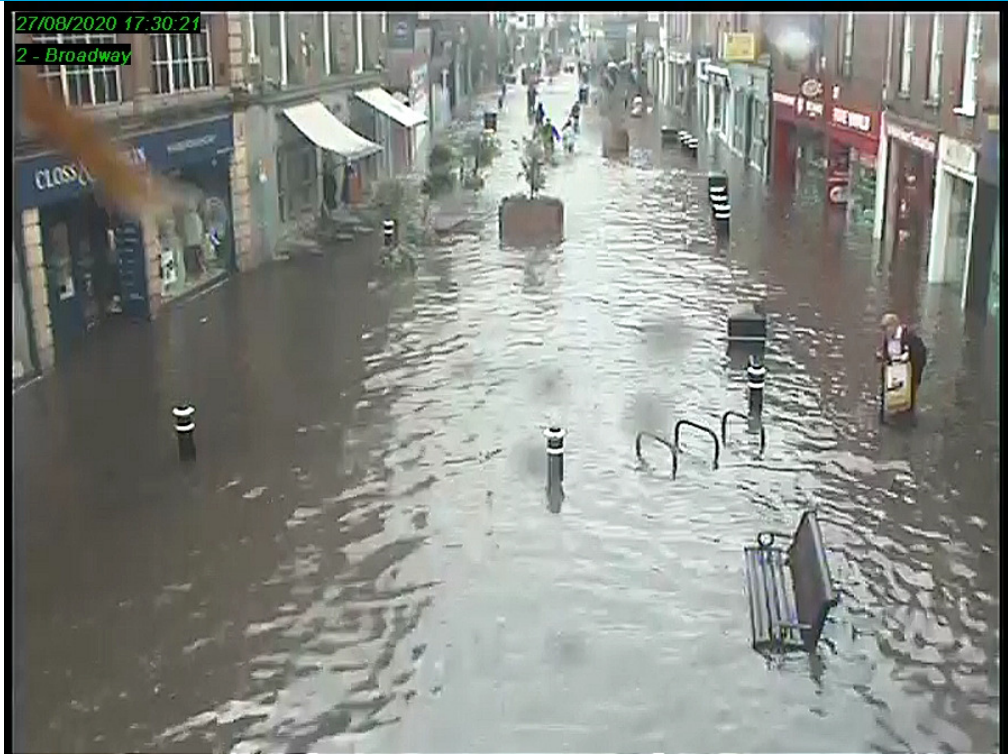
2. Surface water flooding along the Broadway (looking west)

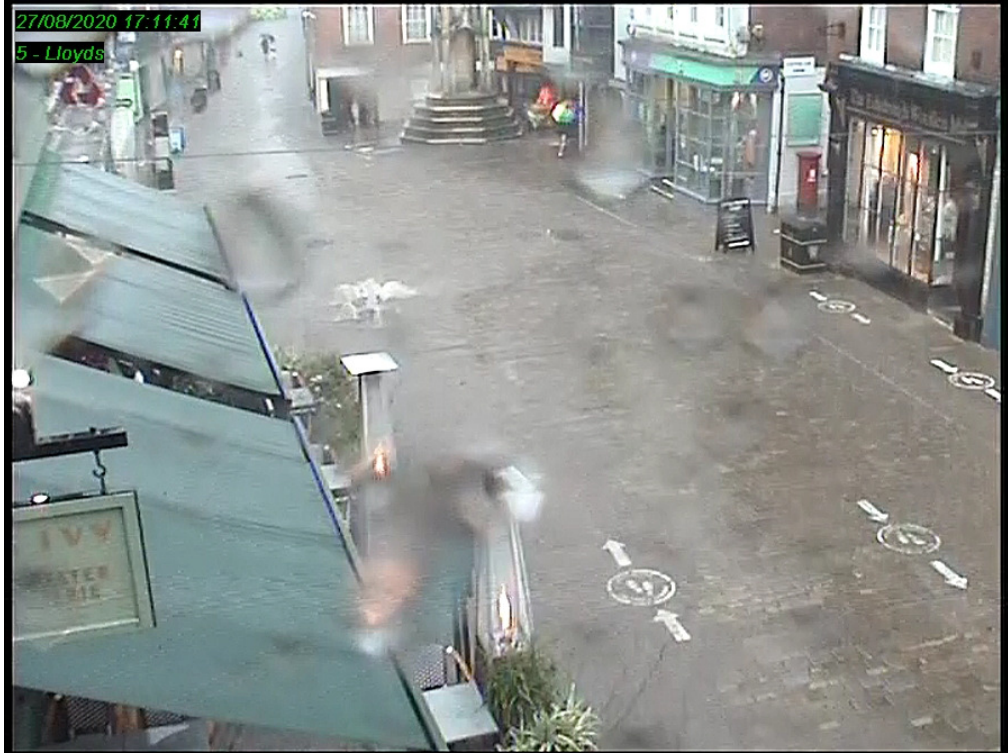
3. Surface water flowing along the High Street (looking east)

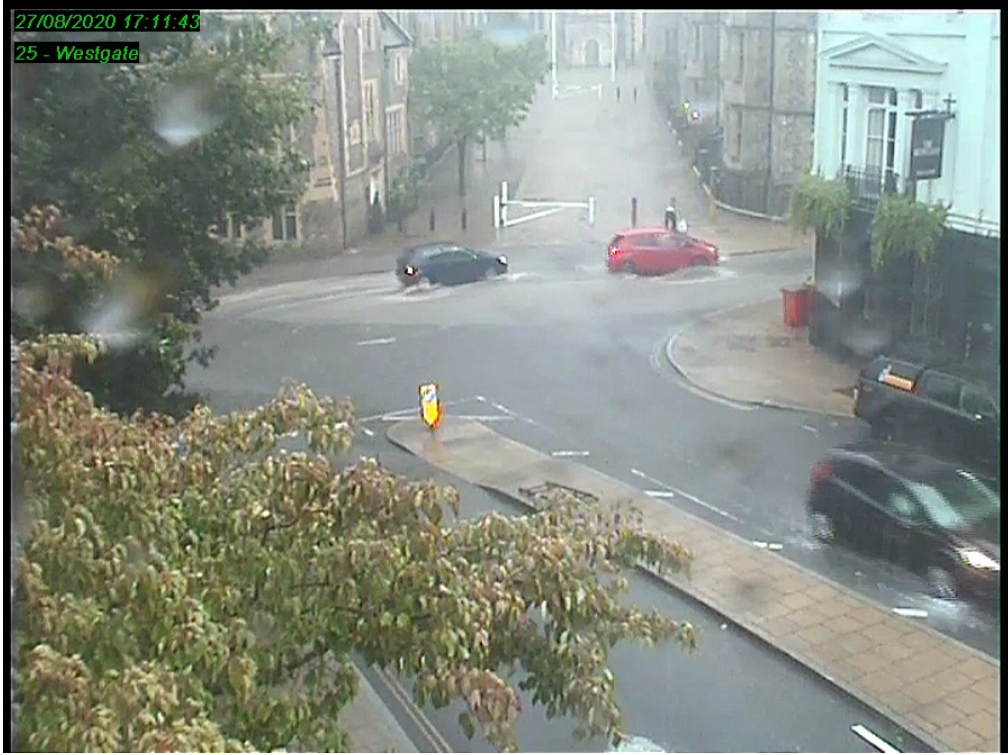
4. Surface water flowing along Romsey Road towards the High Street (looking south east)

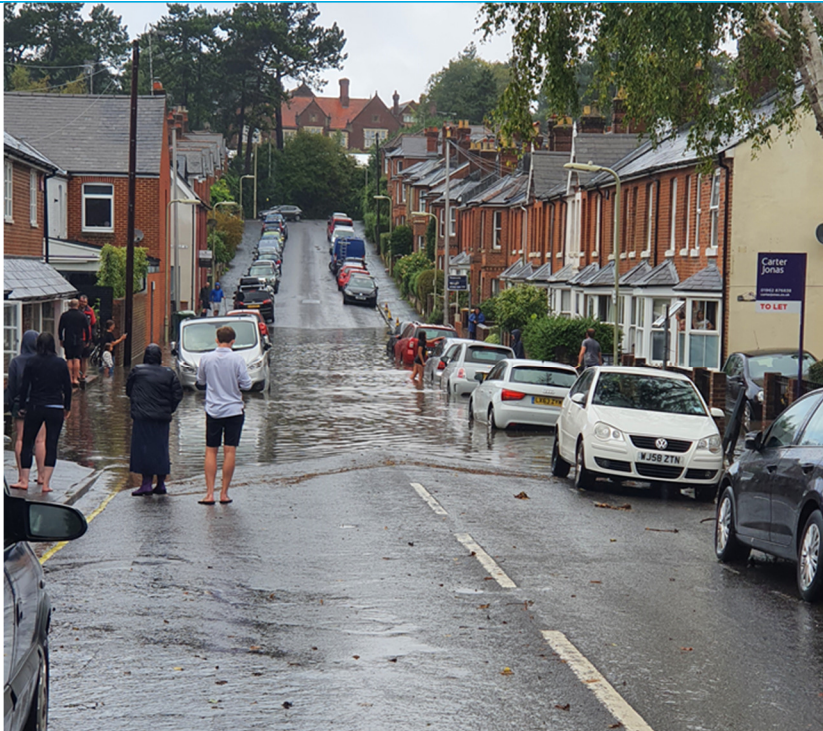
Figure 6-5: Photographs of the flooding in Cranworth Road on 27 August 2020

Surface water flooding in Cranworth Road (looking north)

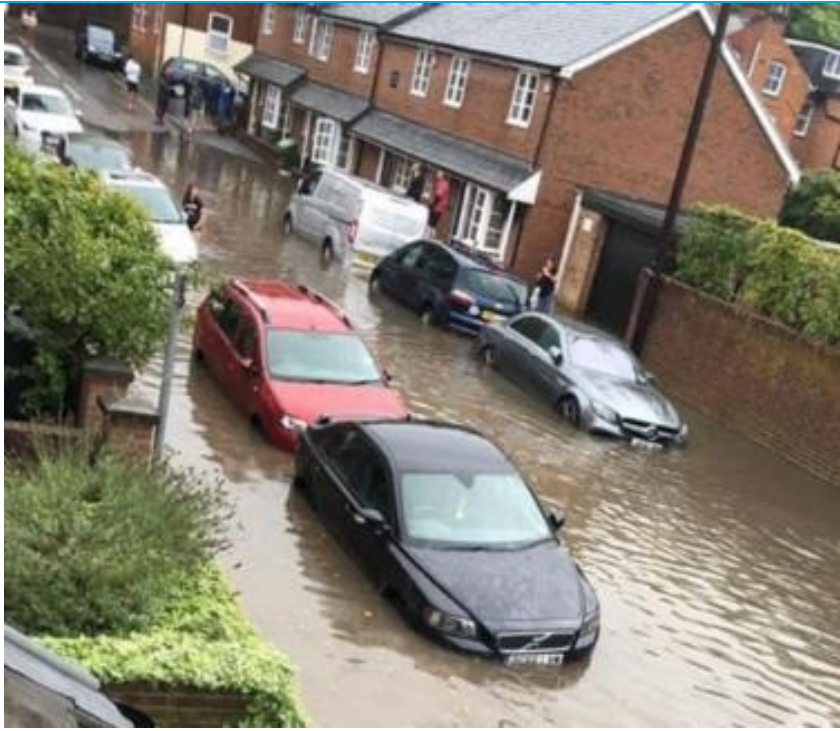
Surface water flooding in Cranworth Road (looking south)

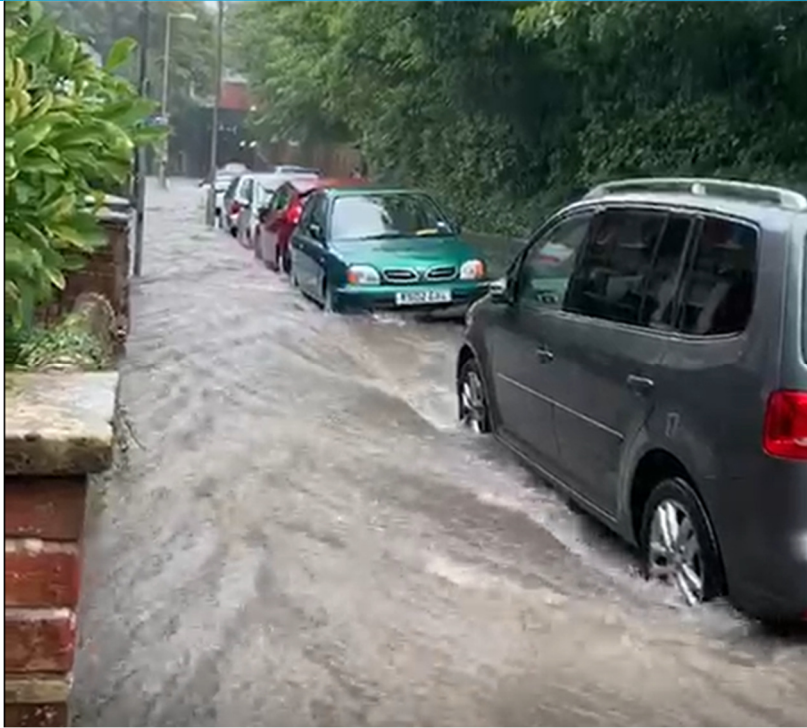
Surface water flowing along Stockbridge Road (looking east)

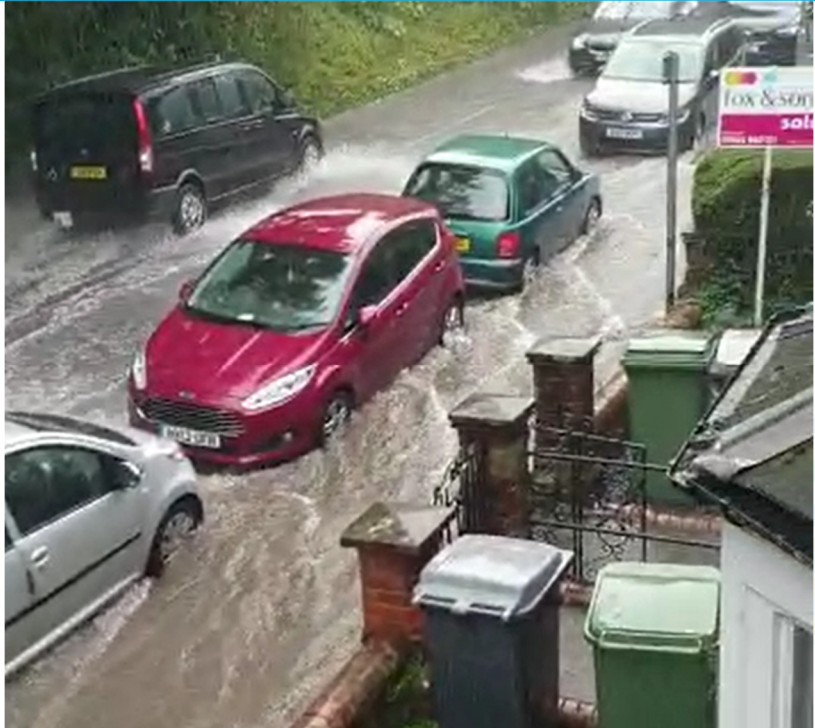
Surface water flowing along Stockbridge Road (looking west)

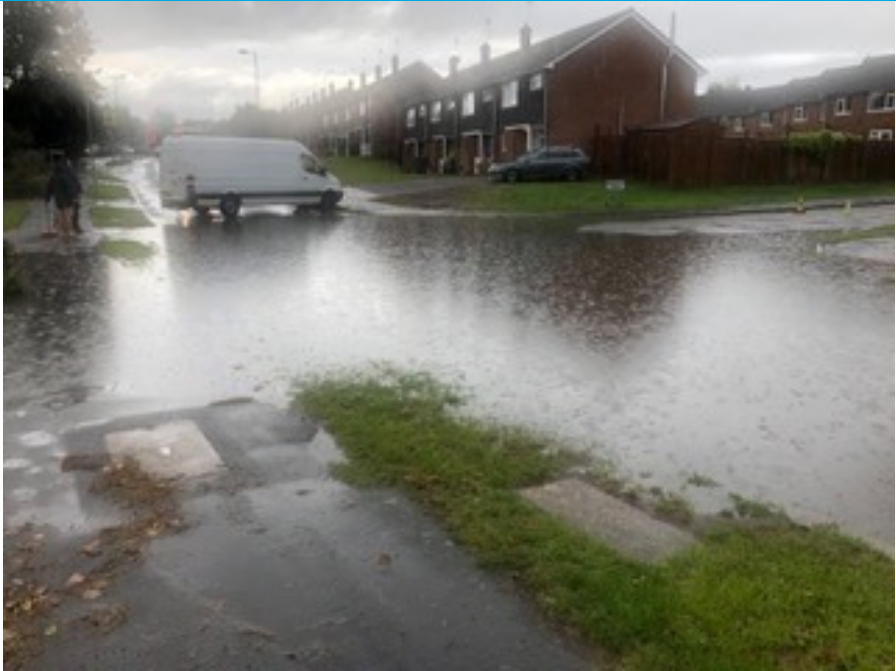
Figure 6-7: Photographs of the Harestock area and flooding on August 27th 2020

1. Surface water flooding at the junction of Buriton Road and Grayshott Close (looking south)

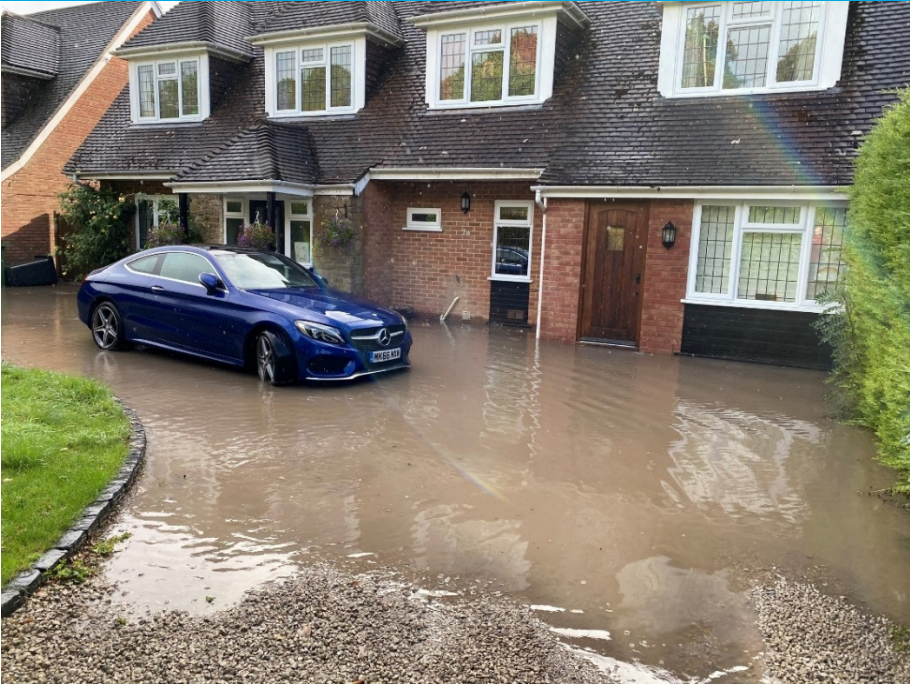
2. Surface water flooding to properties at Andover Road North (looking west)

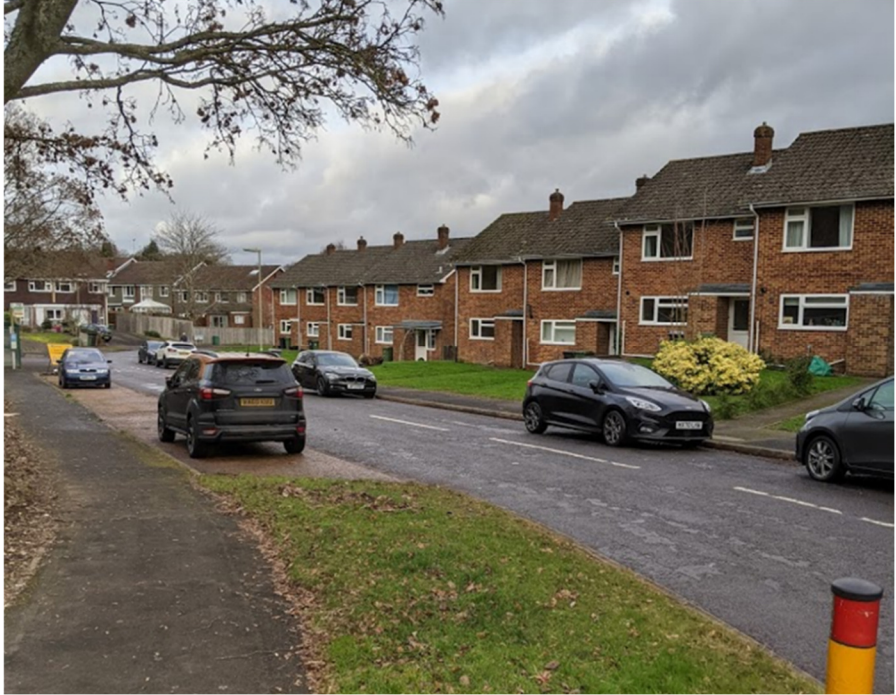
3. Looking north along Bradley Road showing the topography

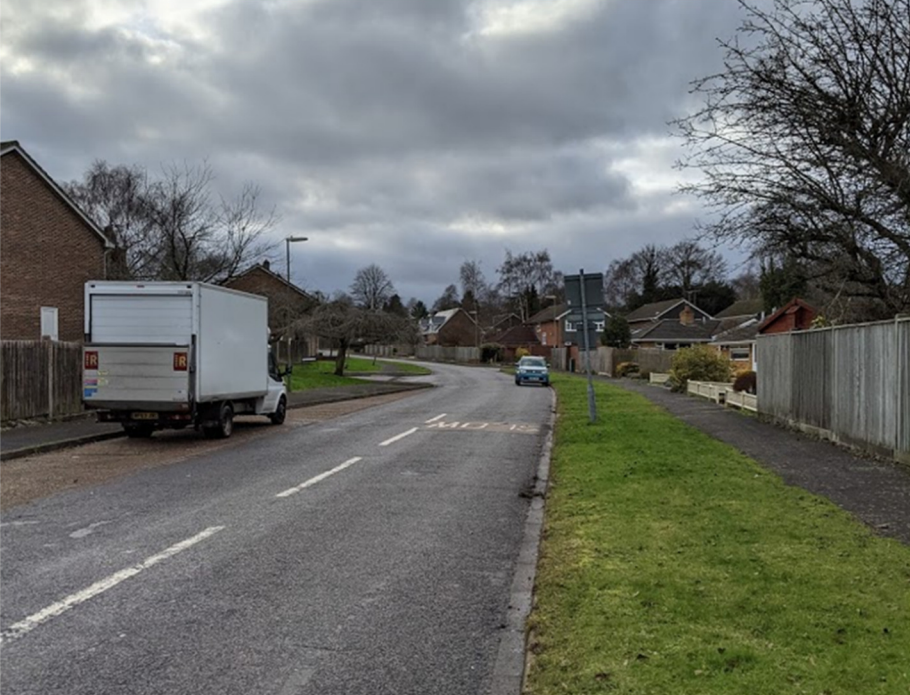
4. Looking north along Priors Dean Road showing the topography

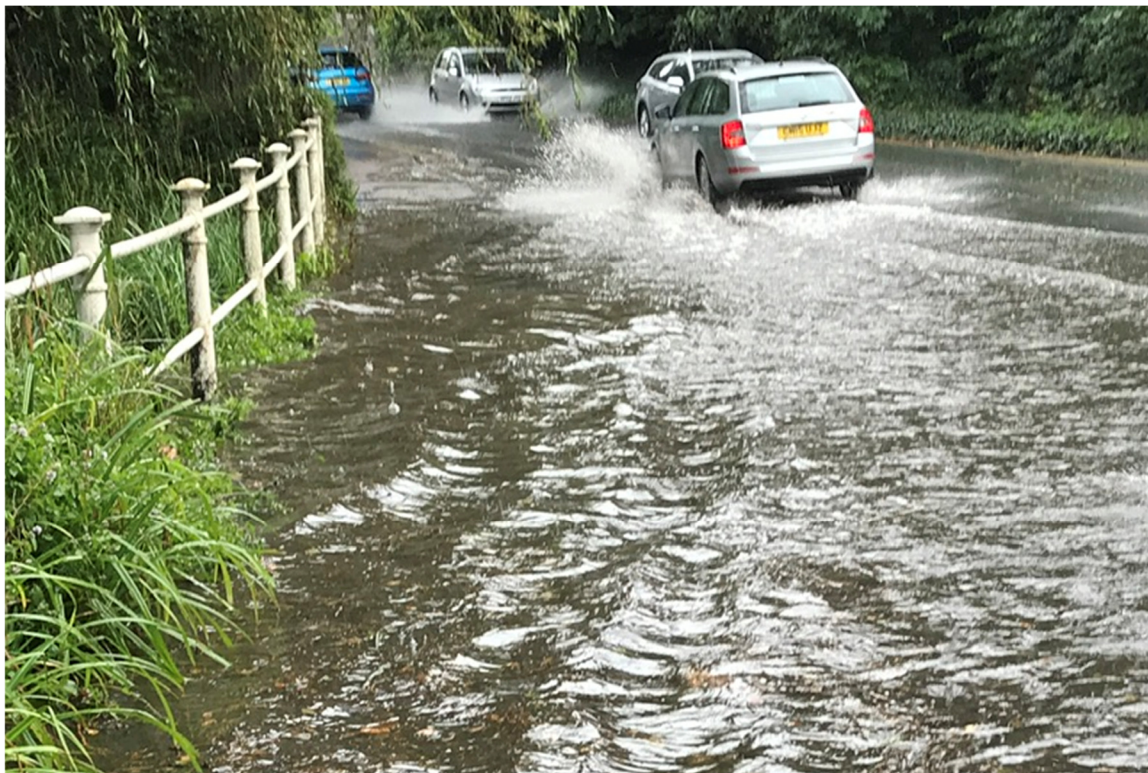
**Figure 6-11: Flooding to Stockbridge Road from Weeke Pond (left) on 27 August**

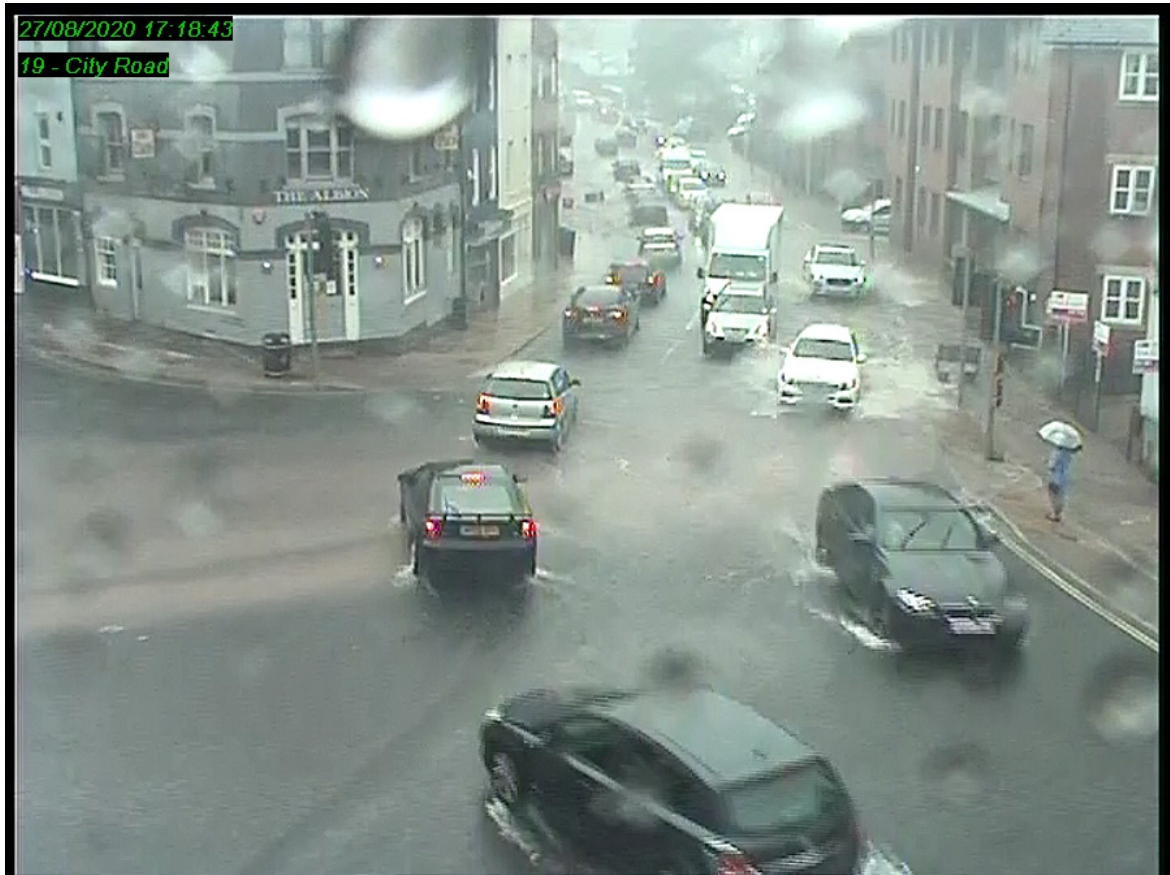
**Figure 6-13: CCTV footage showing flooding on City Road on 27 August**
