The Conservation of

Water Meadows

Structures

Hampshire
County Council

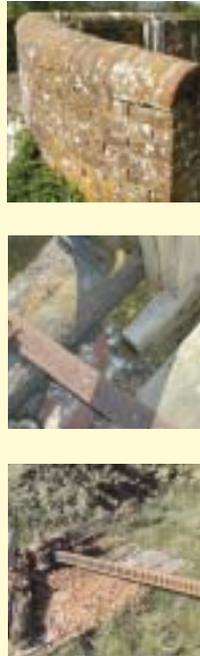
The sluice was used to direct the river from its natural course. In early structures, timber boards were placed by hand into slotted channels in stone or brickwork to control the flow of water. Normally termed 'hatches' these can vary in size from 7, across a main river to a small single 'bunny' hatch, the size of a spade.

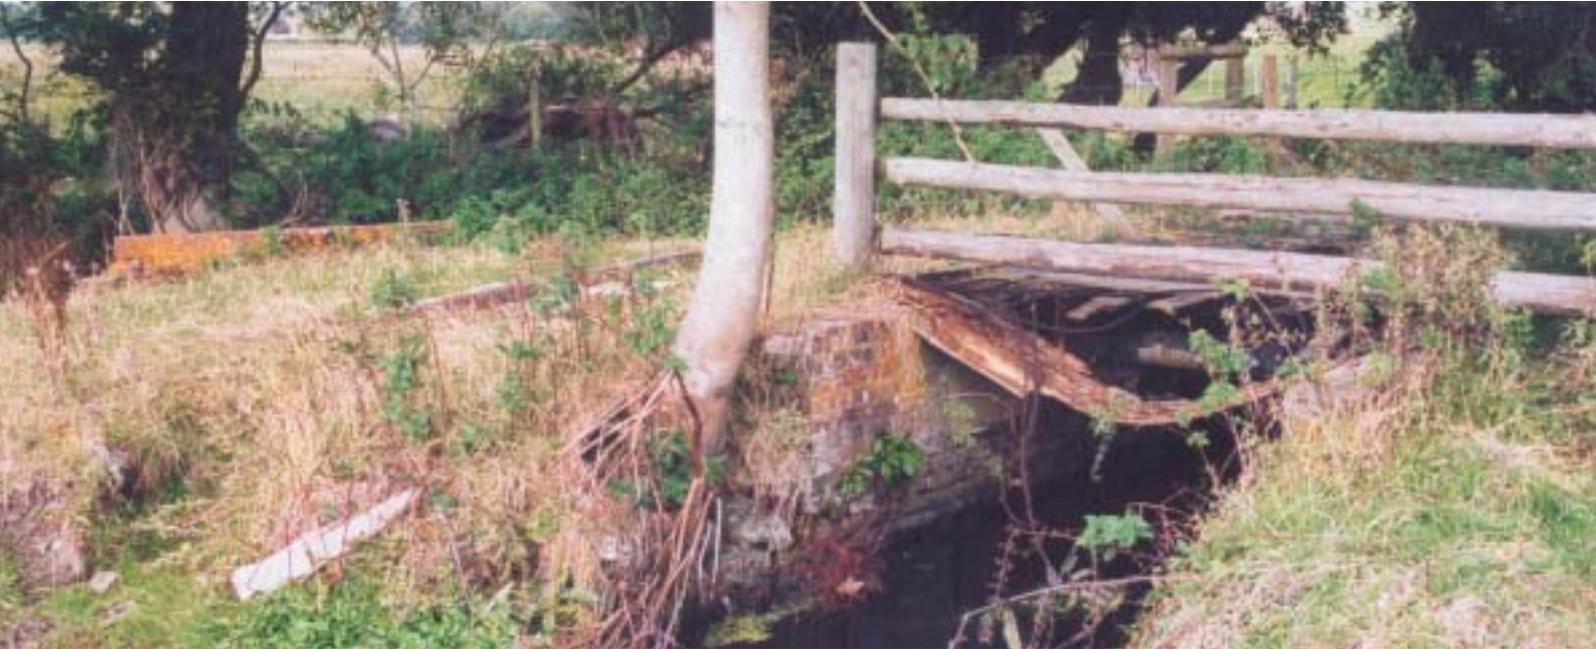
- The river is damned by the **sluice** or hatch or weir and diverted into the **carrier**.
- A **hatch** is opened to let water into the carrier. The hatch is closed when the carrier is not in use to prevent the system from silting up.

- Water from the carrier is let into the water meadow by a subsidiary hatch and is held up by the **stop** and overflows into each part of the meadow in succession. The carriers run along the top of **ridges**, water flowing down the side of the ridge into the **drain** and back to the river. The aim was to achieve a steady flow at a depth through the root mat and stems of the grass sward no greater than 25mm (1 inch).
- In some cases water was directed over the river via **aqueducts** to supply meadows on the other side of a water course, drain or river.
- On many water meadows **bridges** were constructed to enable easier foot and cart access across channels. These may be simple stone slab 'clapper' bridges or more elaborate brick arched structures on later examples. Even later 20th century concrete structures were also used.

It is useful to show how a typical water meadow was operated to explain how the different structures functioned. (See centre pages).

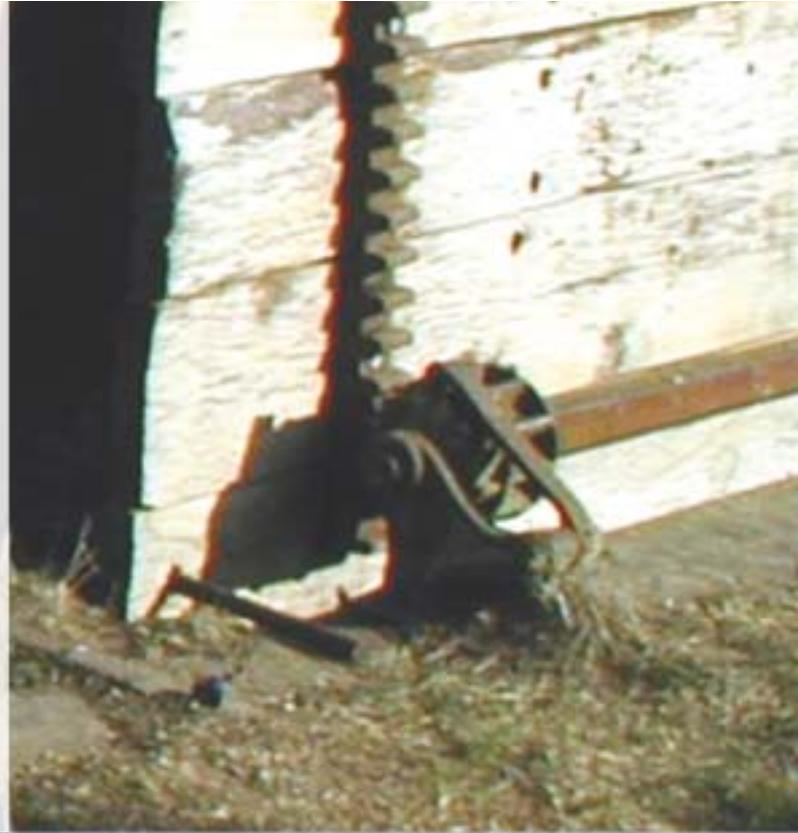
This sluice structure on the River Avon has deteriorated badly. Further delay of the horizontal timber support will result in loss of the cast iron lifting mechanism into the water.

In such a situation, after recording, the structure should be carefully dismantled and stored. Timber sections which are sound should be retained. The replacement of the timber components is relatively straightforward but the cast iron components are both difficult and costly to replace.
