Project Description:

Proposed works to improve public access to the River Hamble – Warsash slipway/hard.

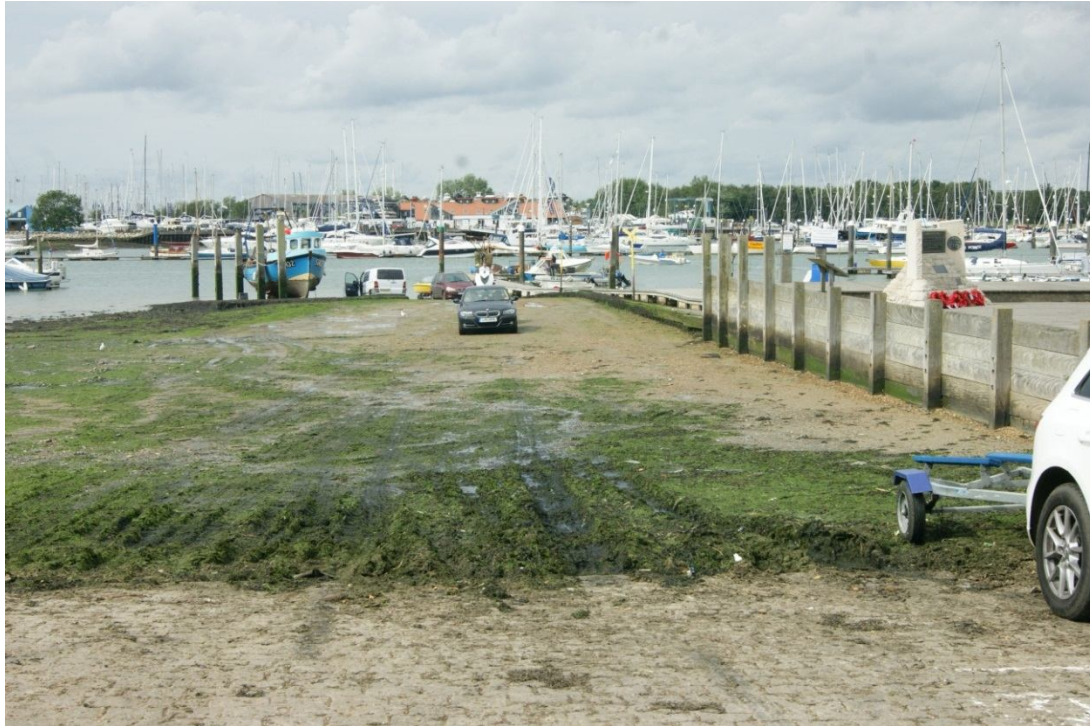
Photo 1 below - The public slipway/hard at Warsash on the River Hamble

The public slipway/hard at Warsash on the River Hamble is by far the most popular and busiest location on the River for public access to launch and recover boats. See photo 1 below. It is used throughout the year but usage peaks during the summer months. The vessels launched and recovered include canoes and kayaks, sailing dinghies, Personal Water Craft (PWCs), Rigid Inflatable Boats (RIBs), larger motor boats and small trailable keelboats and yachts. Many of the users are inexperienced in launching and recovery operations and the present condition and profile of the slipway (described below) can make what should be a straightforward operation into a significant challenge.

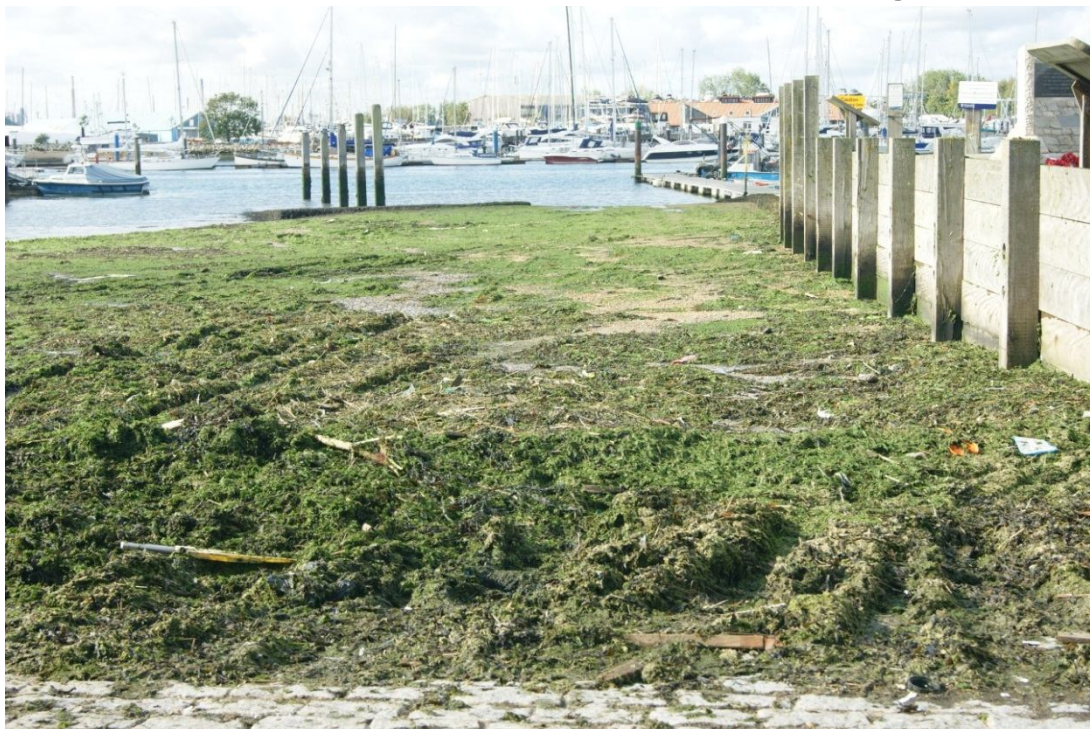
Photo 2 below – Accumulation of sea weed in the absence of regular clearances

- II. The slipway is immediately downstream of a boardwalk with a wooden clad vertical boundary and a concrete training wall which rises about 50cm above the bed level. These features have the effect of trapping **seaweed and other debris** on the strand line at the landward end of the slipway. This can build up to volumes which make access extremely difficult, particularly during the summer months, and require regular clearance at considerable expense. If the seaweed is not cleared at least once per fortnight during the summer, the slipway can become virtually impassable to all but 4x4s. (See photo 2 below).

Seaweed and other debris are currently removed from the landward end of the slipway as compostable waste on a regular basis in order to maintain access. Volumes are in the order of 100 cubic metres per annum. The proposed works are intended to reduce this waste volume considerably, but this cannot be quantified.
