Malthouse Bridge - abutment repair

Malthouse Bridge is a single span Grade II listed arch bridge carrying The Street (C46) at Crookham Village over the Basingstoke Canal. It was built in the late 18th century and is situated in a conservation area and Site of Specific Scientific Interest (SSSI).

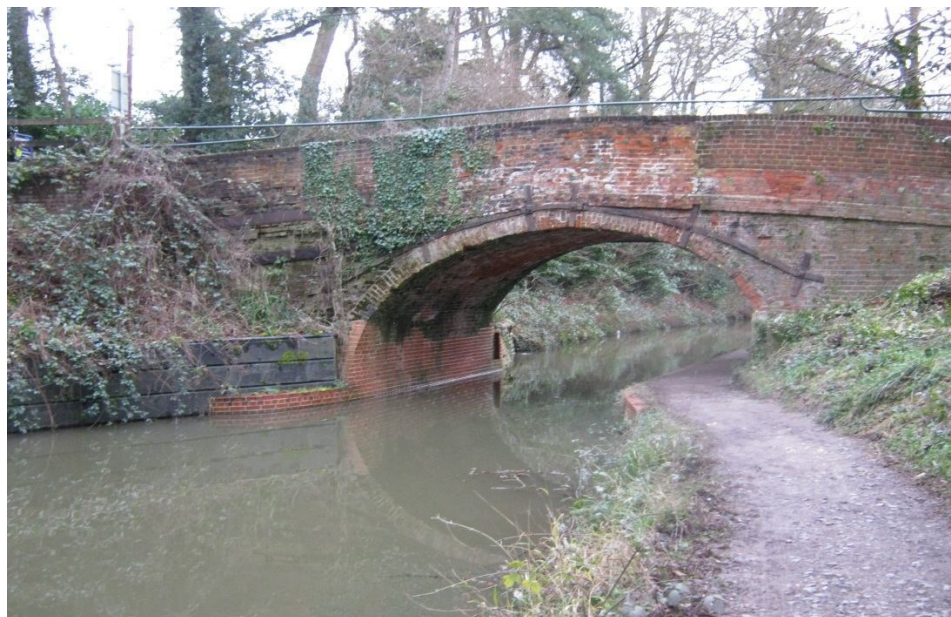
The bridge is constructed from lime mortar and red clay bricks in English bond. A routine inspection indicated spalling/partial collapse of the face of the north abutment. Stability of the bridge was immediately monitored and consultation began with the Canal Authority and Conservation Officers.

Closure of the canal during the navigational season was not permitted, so part of the work had to be carried out in cold weather. A lime mortar method of working was developed with the Lime Centre in Winchester. Over ten weeks repairs were made in small sections, using gradual dewatering of the canal and temporary struts, while monitoring the bridge for any sign of movement.
