# Winchester Section 19 Investigation

## Final Report

June 2021

**Hampshire**  
County Council

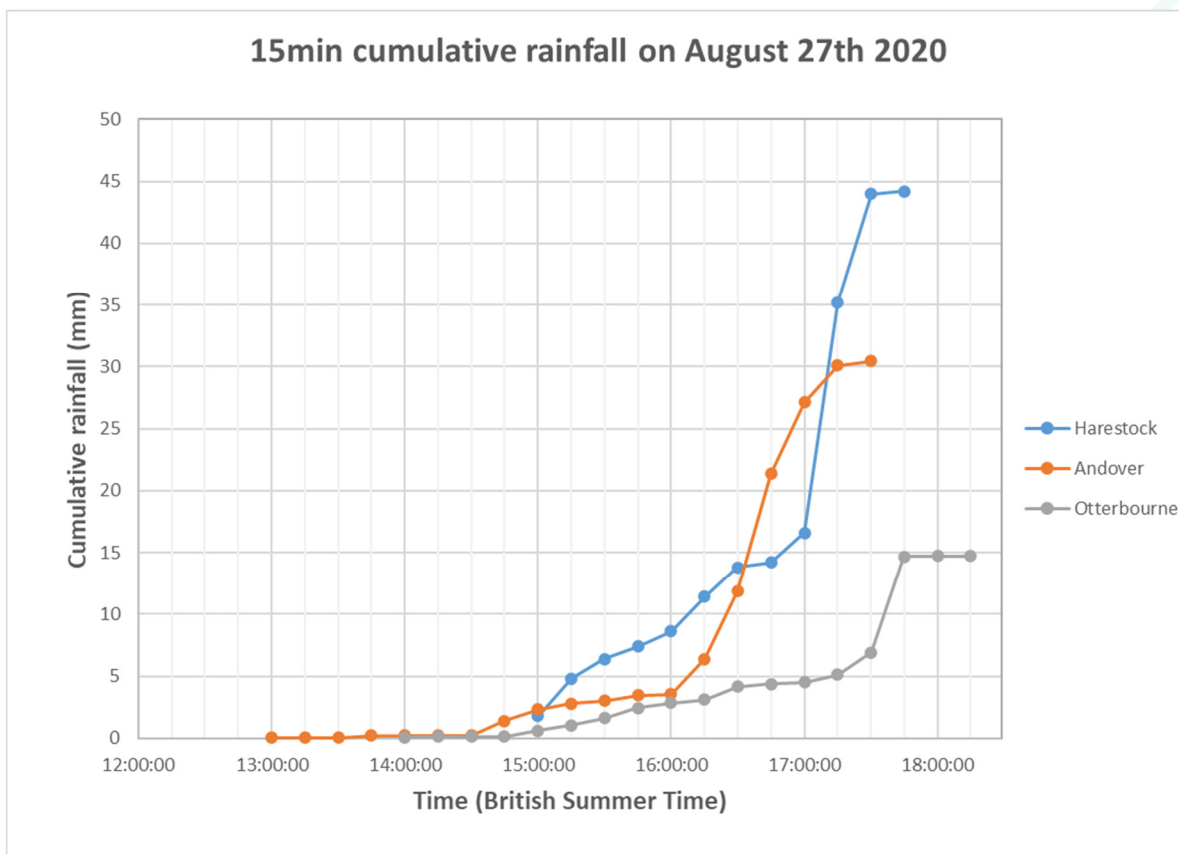
**Figure 5-6: Comparison of rain gauge data on 27 August 2020**

All three rain gauges recorded a distinct peak later in the afternoon where a significant amount more rainfall was recorded than earlier in the afternoon. This occurred at approximately 16:15 in Andover, 16:45 in Harestock and 17:15 in Otterbourne and would indicate that rainfall moved in a roughly north-south direction. This analysis indicated that there were significant differences in rainfall between the three locations with the Harestock gauge recording a significant amount more rainfall than either the Andover or Otterbourne gauges, including earlier in the afternoon, prior to the peak of the event.

The main peak of the event occurred at 16:45 in Harestock, by which time the gauge had recorded 14.20mm of rainfall over the preceding 1hr 45 mins, this was a similar amount of rainfall recorded by the Otterbourne gauge, which recorded 14.74mm of rainfall over the entire event. A total of 44mm of rainfall was recorded over the entire event by the Harestock Gauge, with 27.4mm recorded between 17:00 – 17:30.

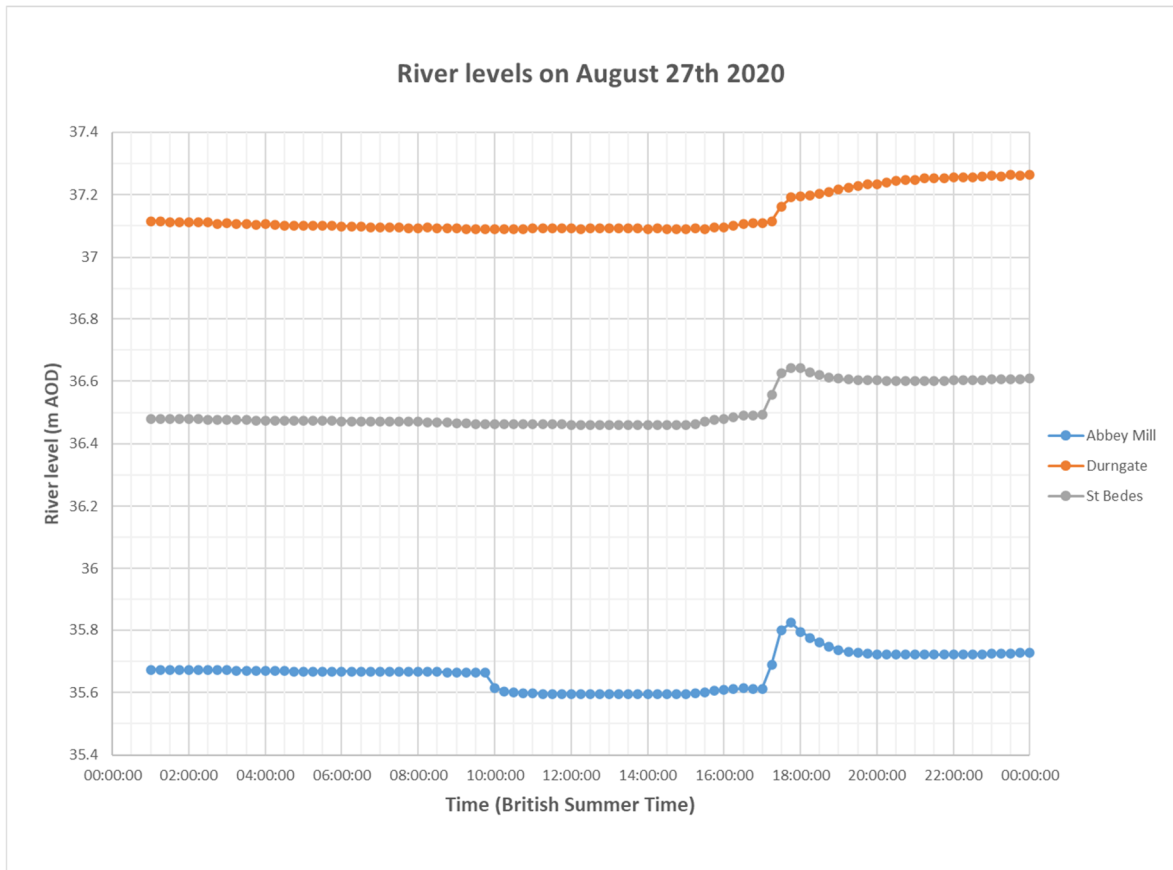
**Figure 5-8: River gauge data on 27 August**

Analysis of river gauge data from the River Itchen before, during and after the 27 August event indicate that river levels were at a normal level for August prior to the event. However, a consistent peak was indicated on the day of the event for all five of the river gauges for which data was requested.

Further analysis of the event data shows that the increase in river level started at approximately 17:00, for the majority of gauges this continued to rise rapidly until reaching a peak at 17:45. River levels then slowly decreased before returning to pre-event levels on 29 August. It should be noted that the increase in river level was relatively minimal, with the increase limited to approximately 200mm above normal levels during the peak.

Responses to the stakeholder engagement surveys in Section 5.1.2 identified that the most intense rainfall and surface water flooding occurred from 16:45 – 17:20, this is before the peak in river levels identified from the gauge data. The surface water drainage system in High Street was noted to have started to clear flood waters within 20 mins of the peak of the flood event, if surface water drainage systems had been surcharged by high river levels in the Itchen it is unlikely that these systems would have been able to discharge the flood water in the High Street so quickly.

It is more likely that this system did not have the capacity to cope with the large volumes of surface water runoff generated from the event and it is unlikely that the flooding would have been a result of high river levels.

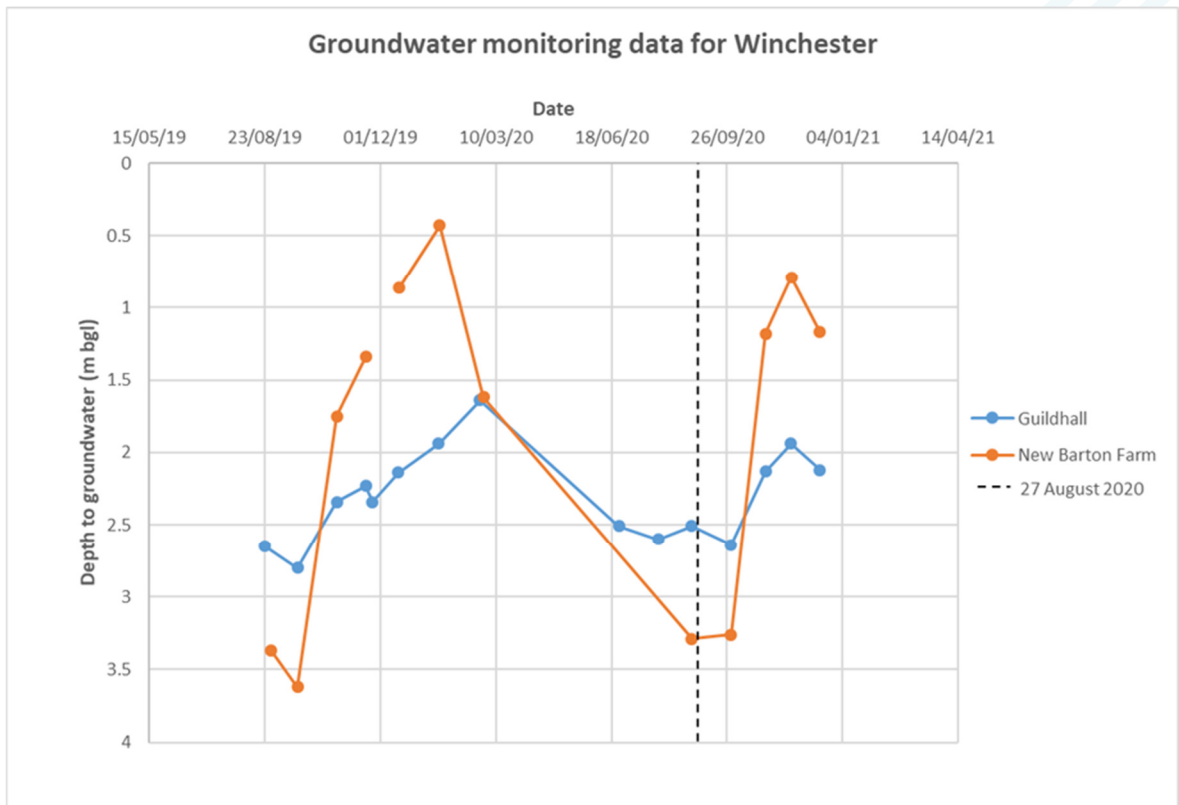
**Figure 5-10: Groundwater monitoring data for Winchester**

The data indicates that groundwater levels were approximately 2.5 – 3.5m below ground level during August 2020, this is relatively consistent with data from August 2019. This data follows the general pattern of groundwater levels being at their lowest levels during the summer months and higher during Autumn – Spring. Based on the timing of the flood event, it is unlikely that high groundwater levels would have had an impact on the 27 August flooding.

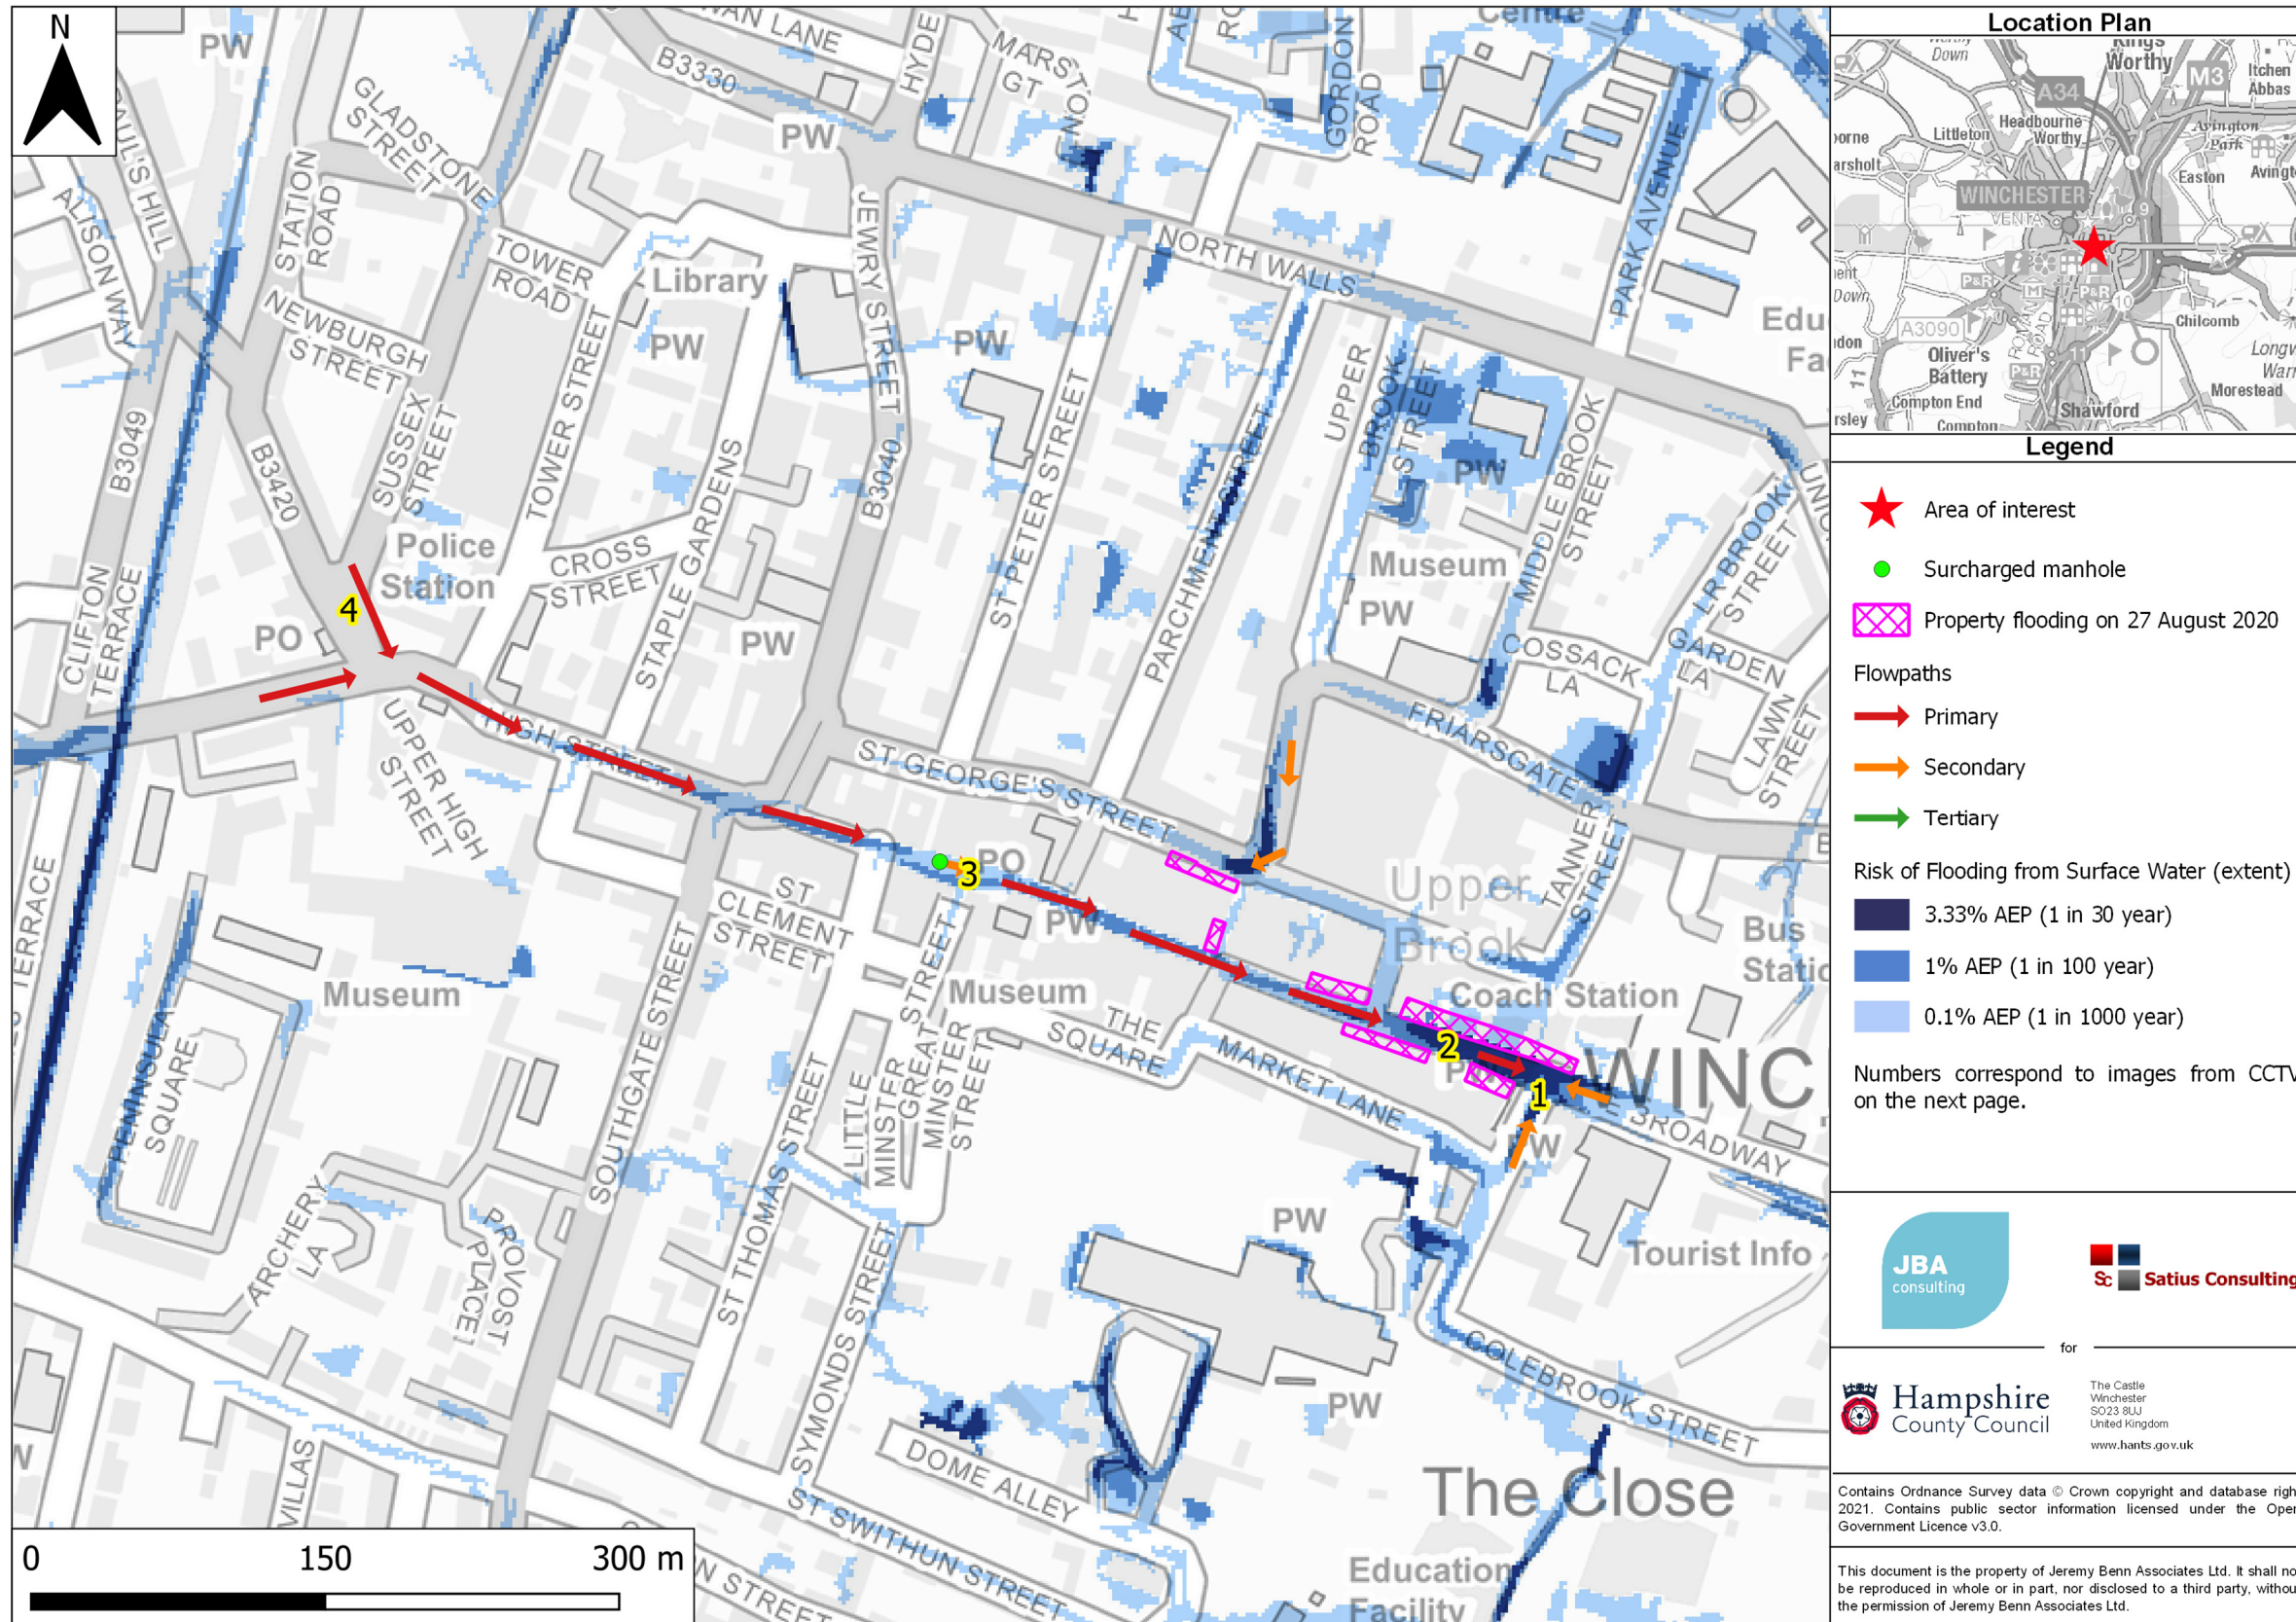
**Figure 6-2: Source-Pathway-Receptor mapping for Winchester High Street**

CCTV footage from the event shows manhole covers lifting in the High Street (location 3 Figure 6-3), it is likely that this is the result of a hydraulic overload, and this may have acted as a secondary source of flooding once drainage systems became surcharged. This may have exacerbated surface water flooding in the area, however the primary source of the flooding is considered to be surface water runoff as a result of the steep topography.

CCTV footage from the town centre (location 4, Figure 6-3) indicates that surface water runoff flowed down Romsey Road towards the High Street. Surface water continued to flow down the High Street (location 3, Figure 6-3) before pooling in the Broadway (location 2, Figure 6-3). The Broadway continues east where it is slightly elevated, which causes surface water to pool in this location.

The low thresholds of the commercial properties along the High Street may have exacerbated the number of properties flooded and flood damage in comparison to residential dwellings in Winchester. This resulted in damage to flooring and equipment for businesses in the High Street in addition to loss of trade resulting from the flooding, although many businesses managed to reopen the following day.

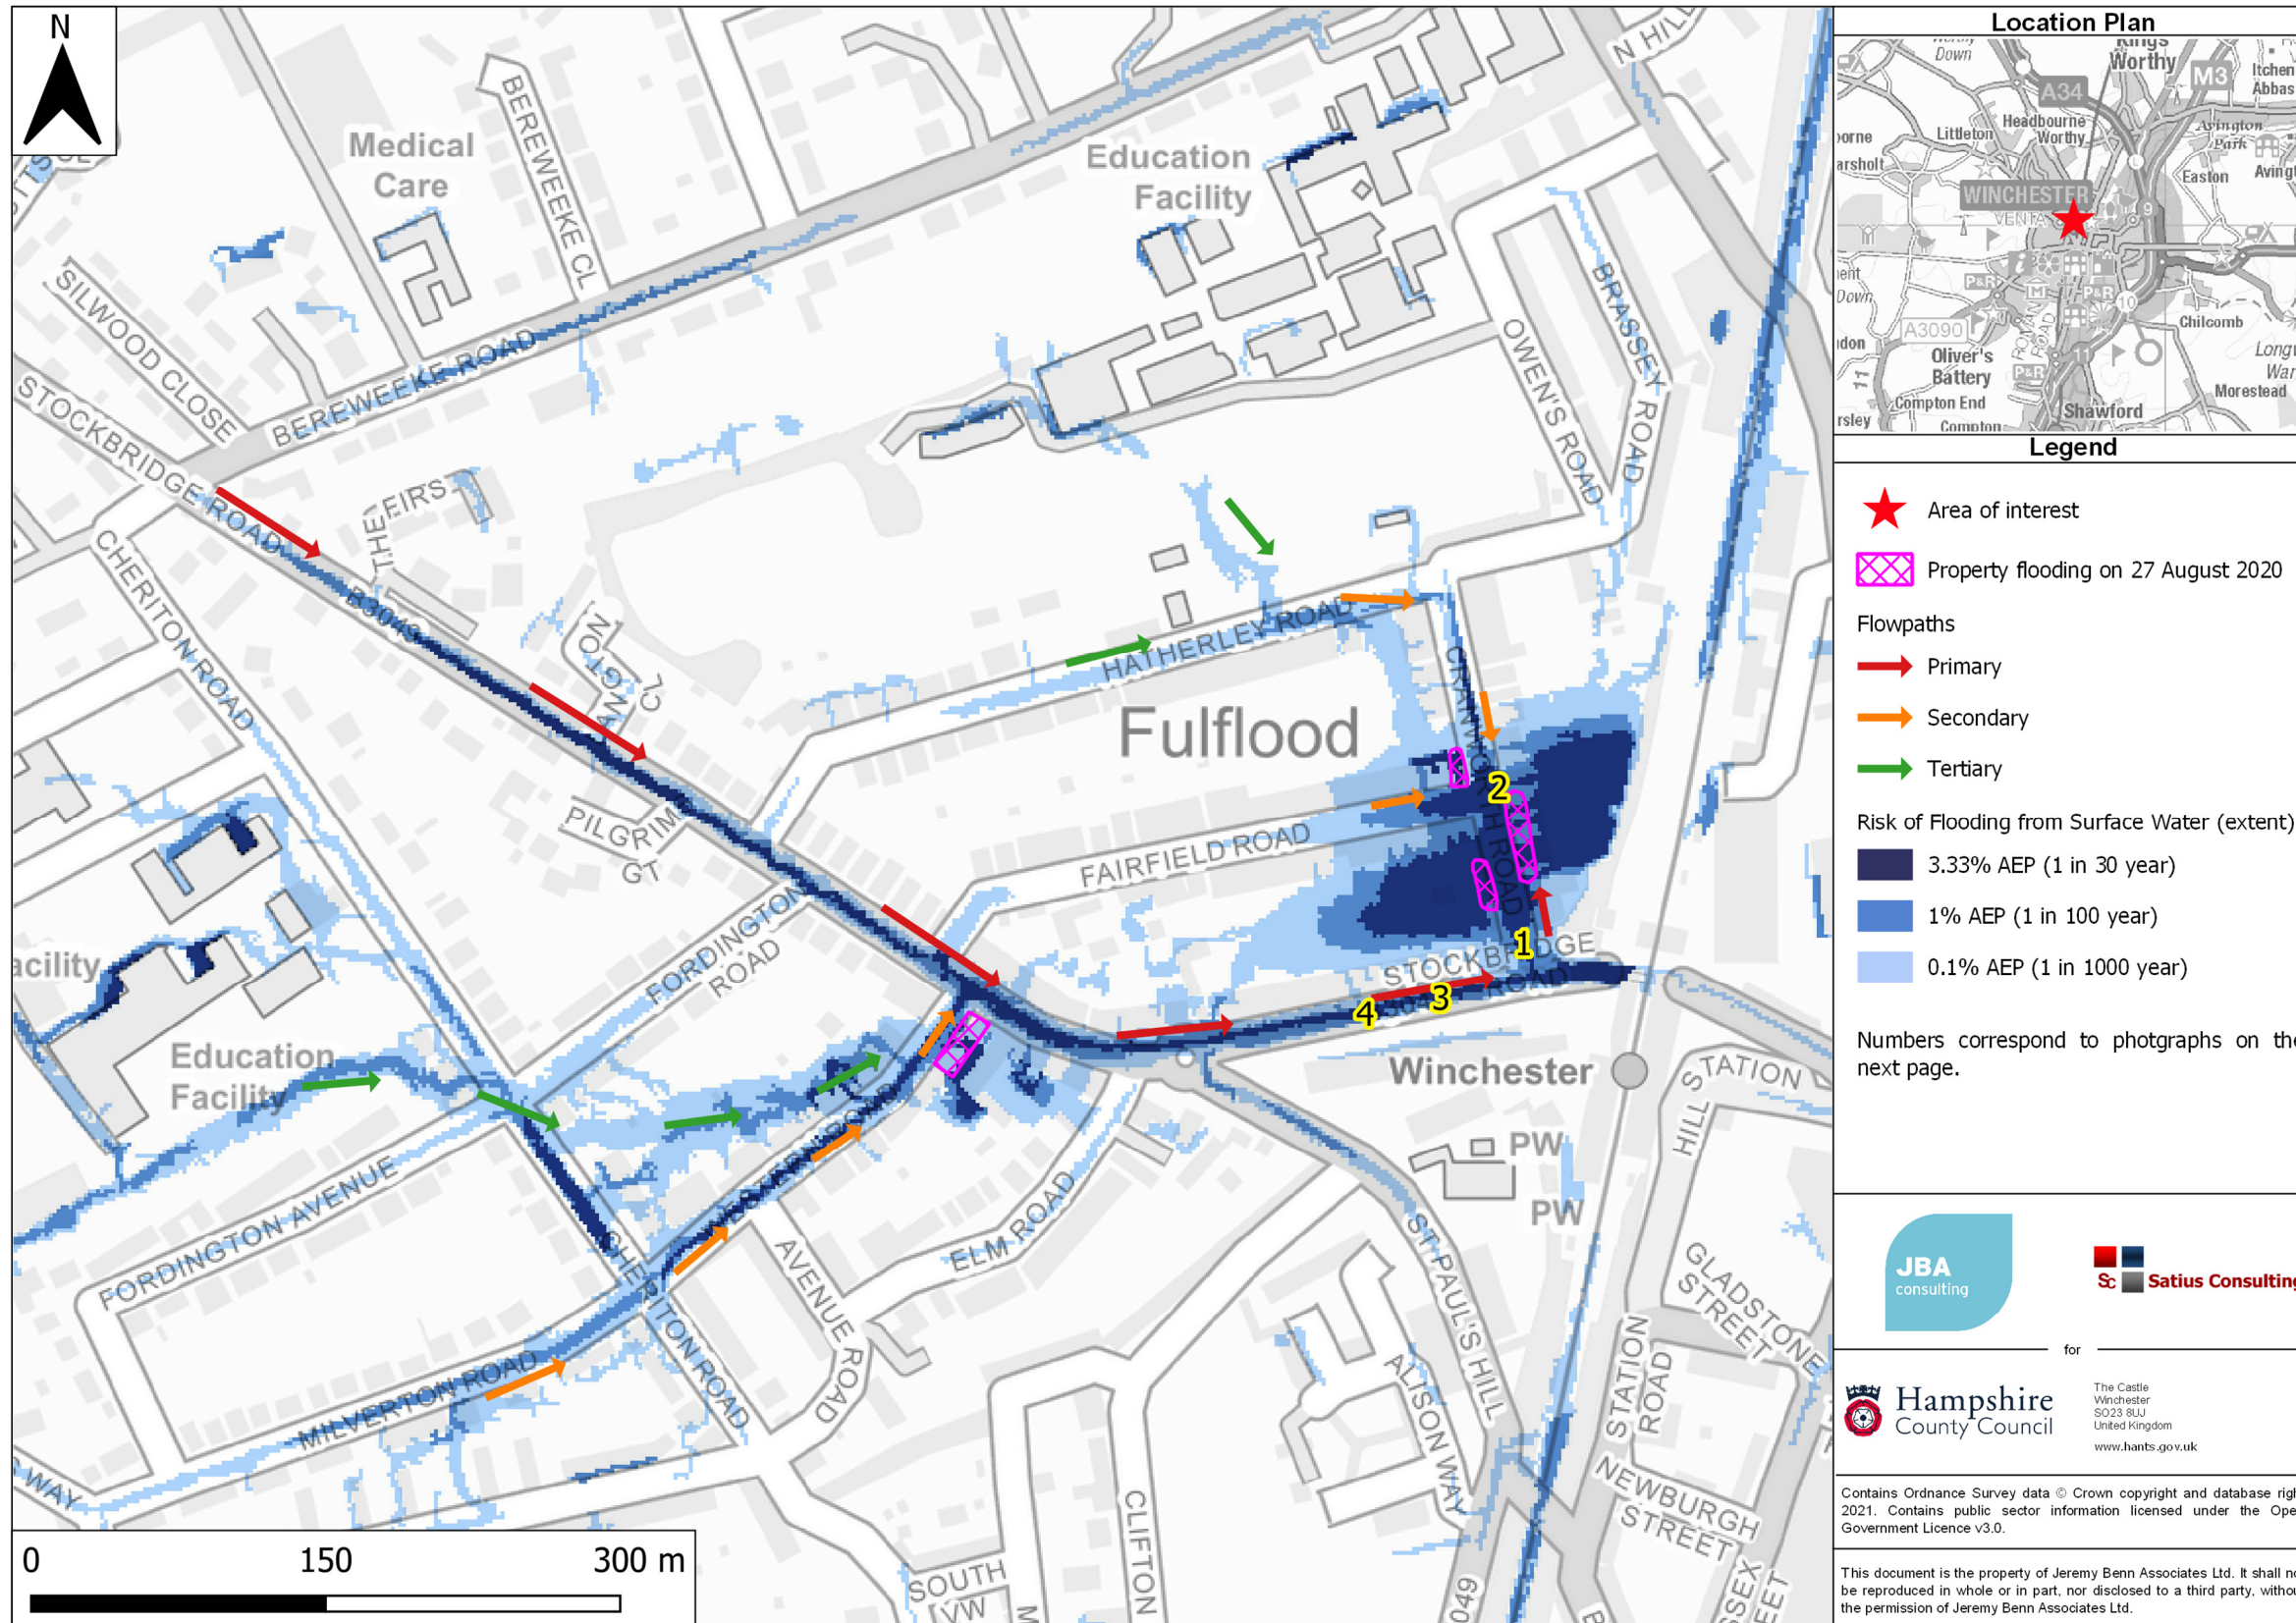
**Figure 6-4: Source-Pathway-Receptor mapping for Cranworth Road on 27 August 2020**

Responses to the stakeholder engagement survey indicate that surface water runoff also flowed along adjoining roads including Fairfield Road and Hatherley Road before pooling in the low spot in Cranworth Road. Surface water flows were also noted to have originated to the south east, flowing along Milverton Road and Western Road before converging with the main flow path flowing east along Stockbridge Road, these secondary and tertiary flow paths are indicated in Figure 6-4.

Water is also known to have entered the tunnel under the railway line causing flooding to a depth of approximately 120mm, this was noted to be a recurrent issue. As a result of the

The Risk of Flooding from Surface Water mapping shows flood extents along Cranworth Road to be extremely large during the 3.3 AEP event, with only a small amount of water flowing through the tunnel on Stockbridge Road during the 0.1% AEP event. Responses from the stakeholder engagement survey indicate that flooding in this location is recurrent. It is unlikely the tunnel has been accurately represented on the RoFSW mapping. Although these areas of Cranworth Road are likely to be at 'high' risk of flooding from surface water, as indicated from the 27 August flooding, the extents are unlikely to be as large as the mapping would indicate.

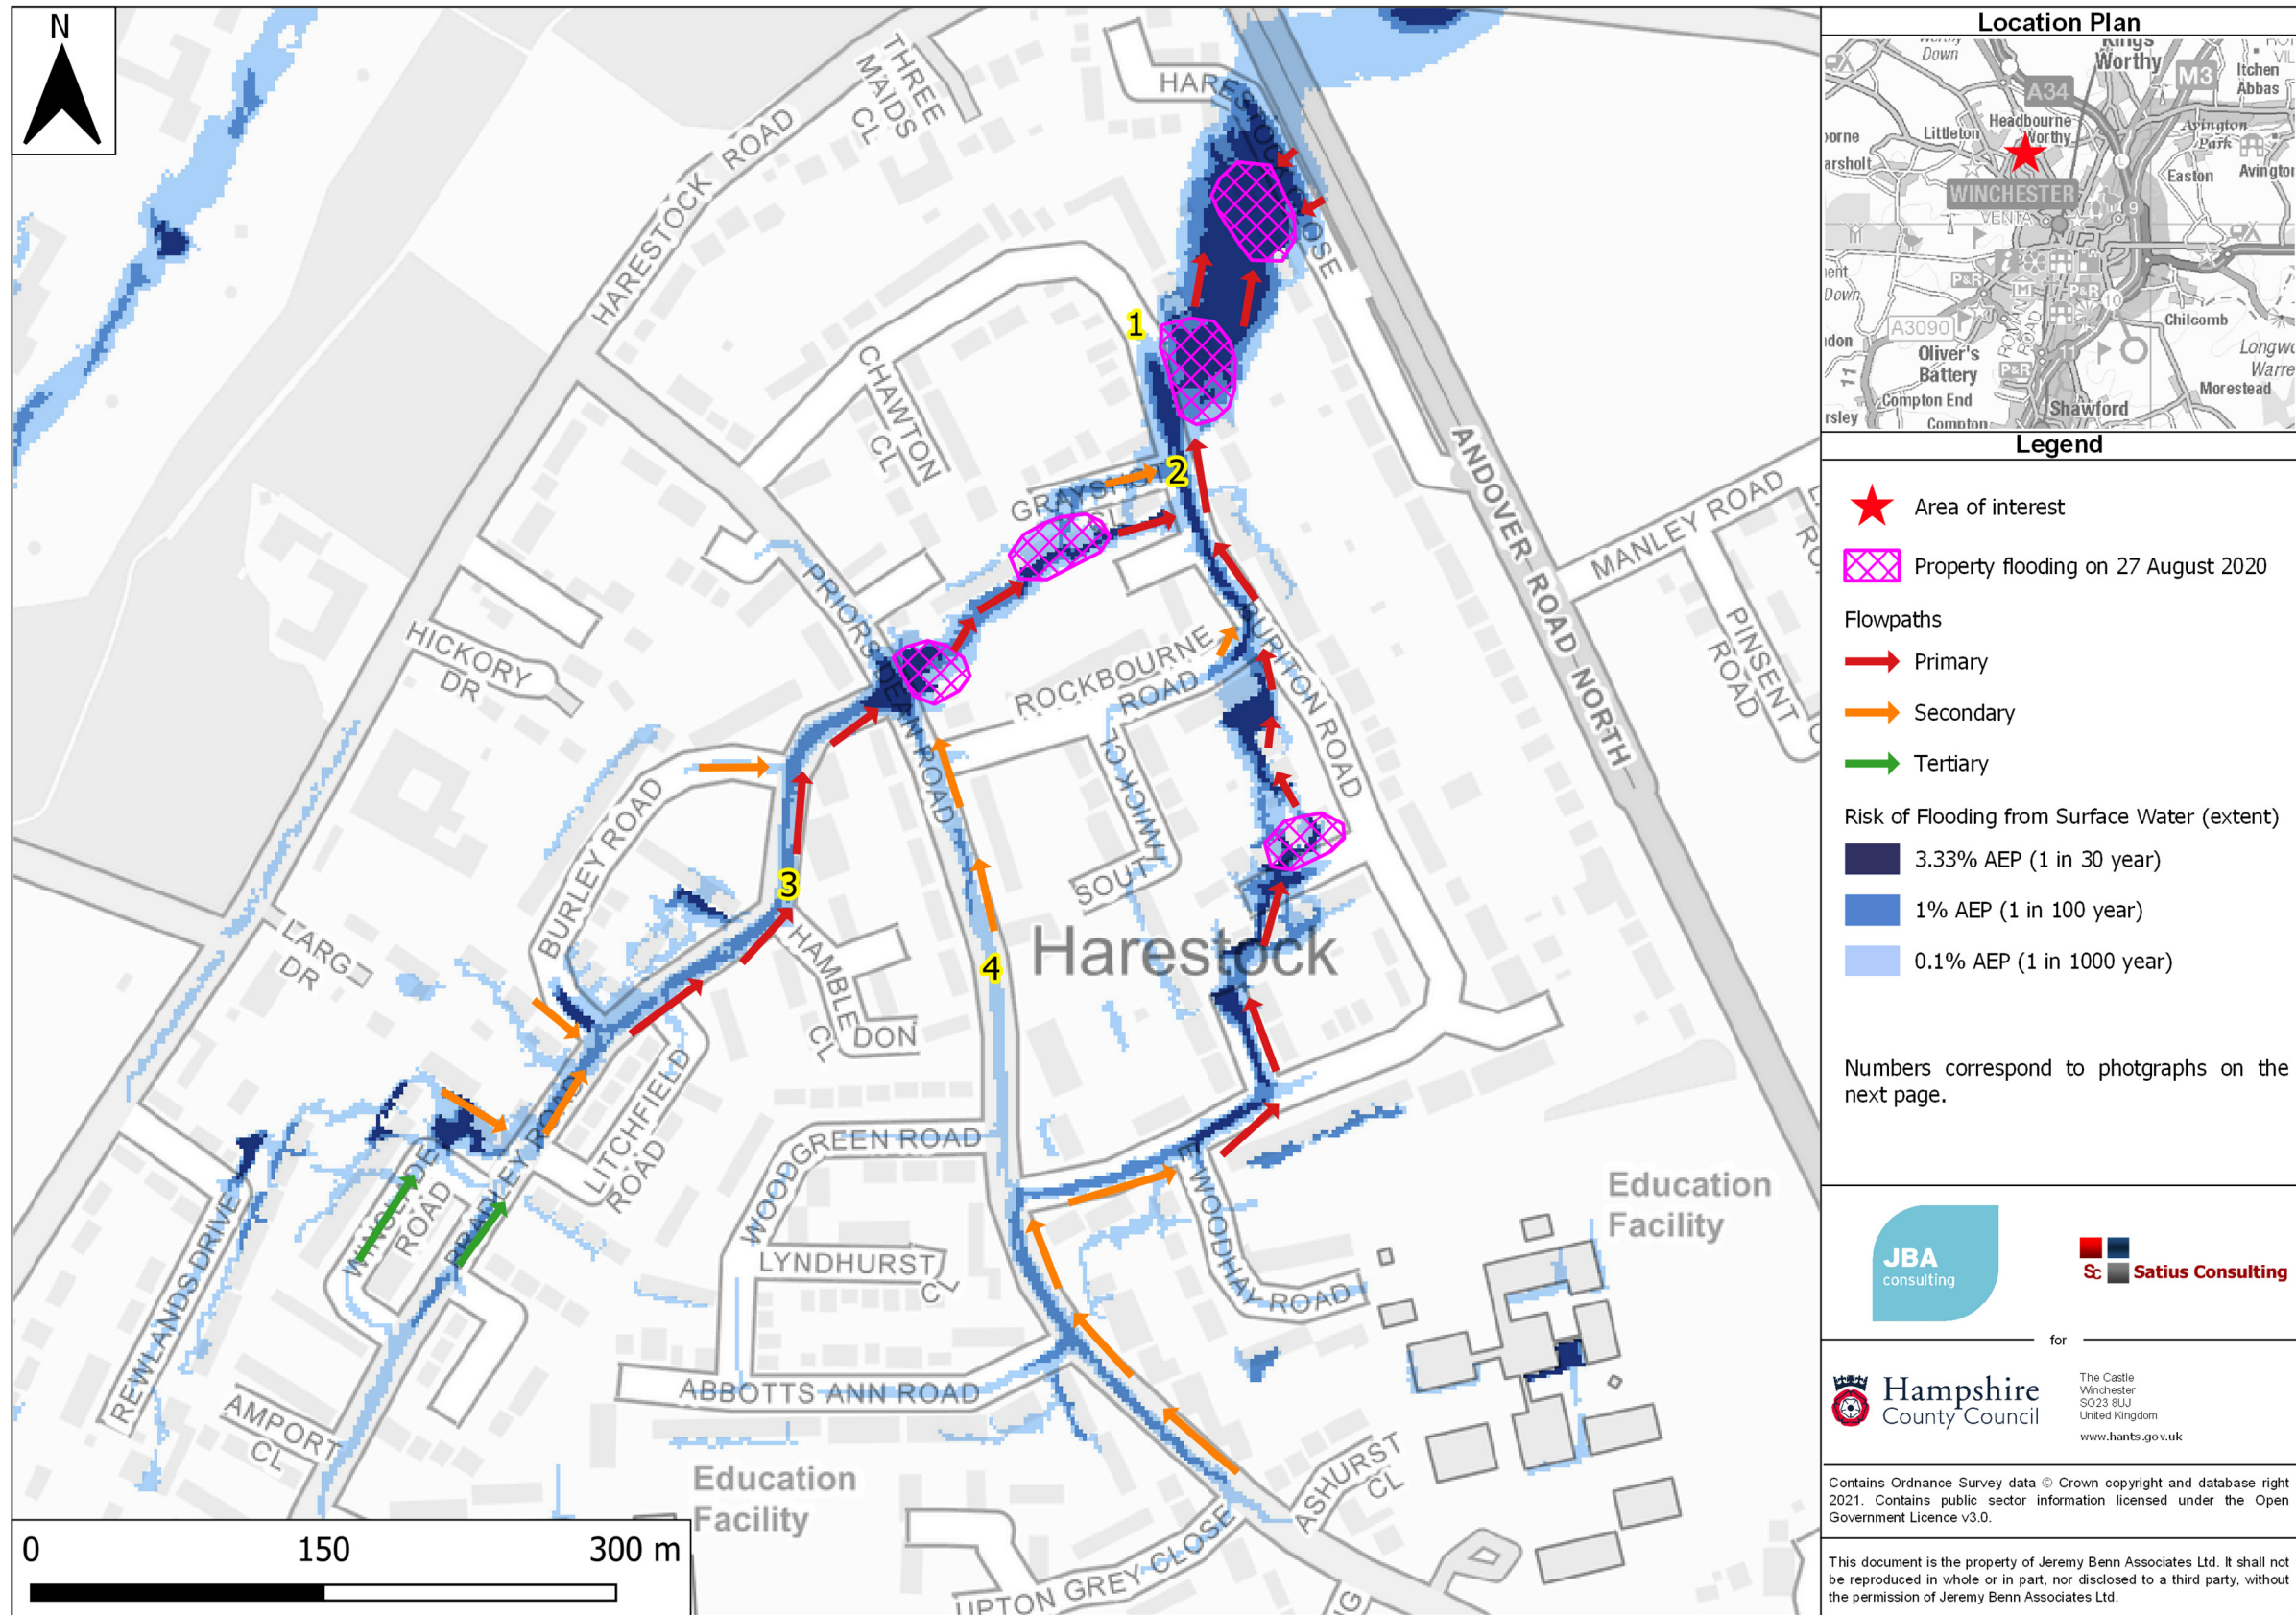
**Figure 6-6: Source-Pathway-Receptor mapping in Harestock on 27 August**

From this information, it can be inferred that the Risk of Flooding from Surface Water mapping is a good indicator of the flooding mechanisms in this area, as experienced on 27 August and flooding was mainly a result of the steep topography of the area. These flow paths are indicated in Figure 6-6.

As a result of the flooding, many homeowners keep sandbags outside their properties as seen on the site visit on 11 January 2021.

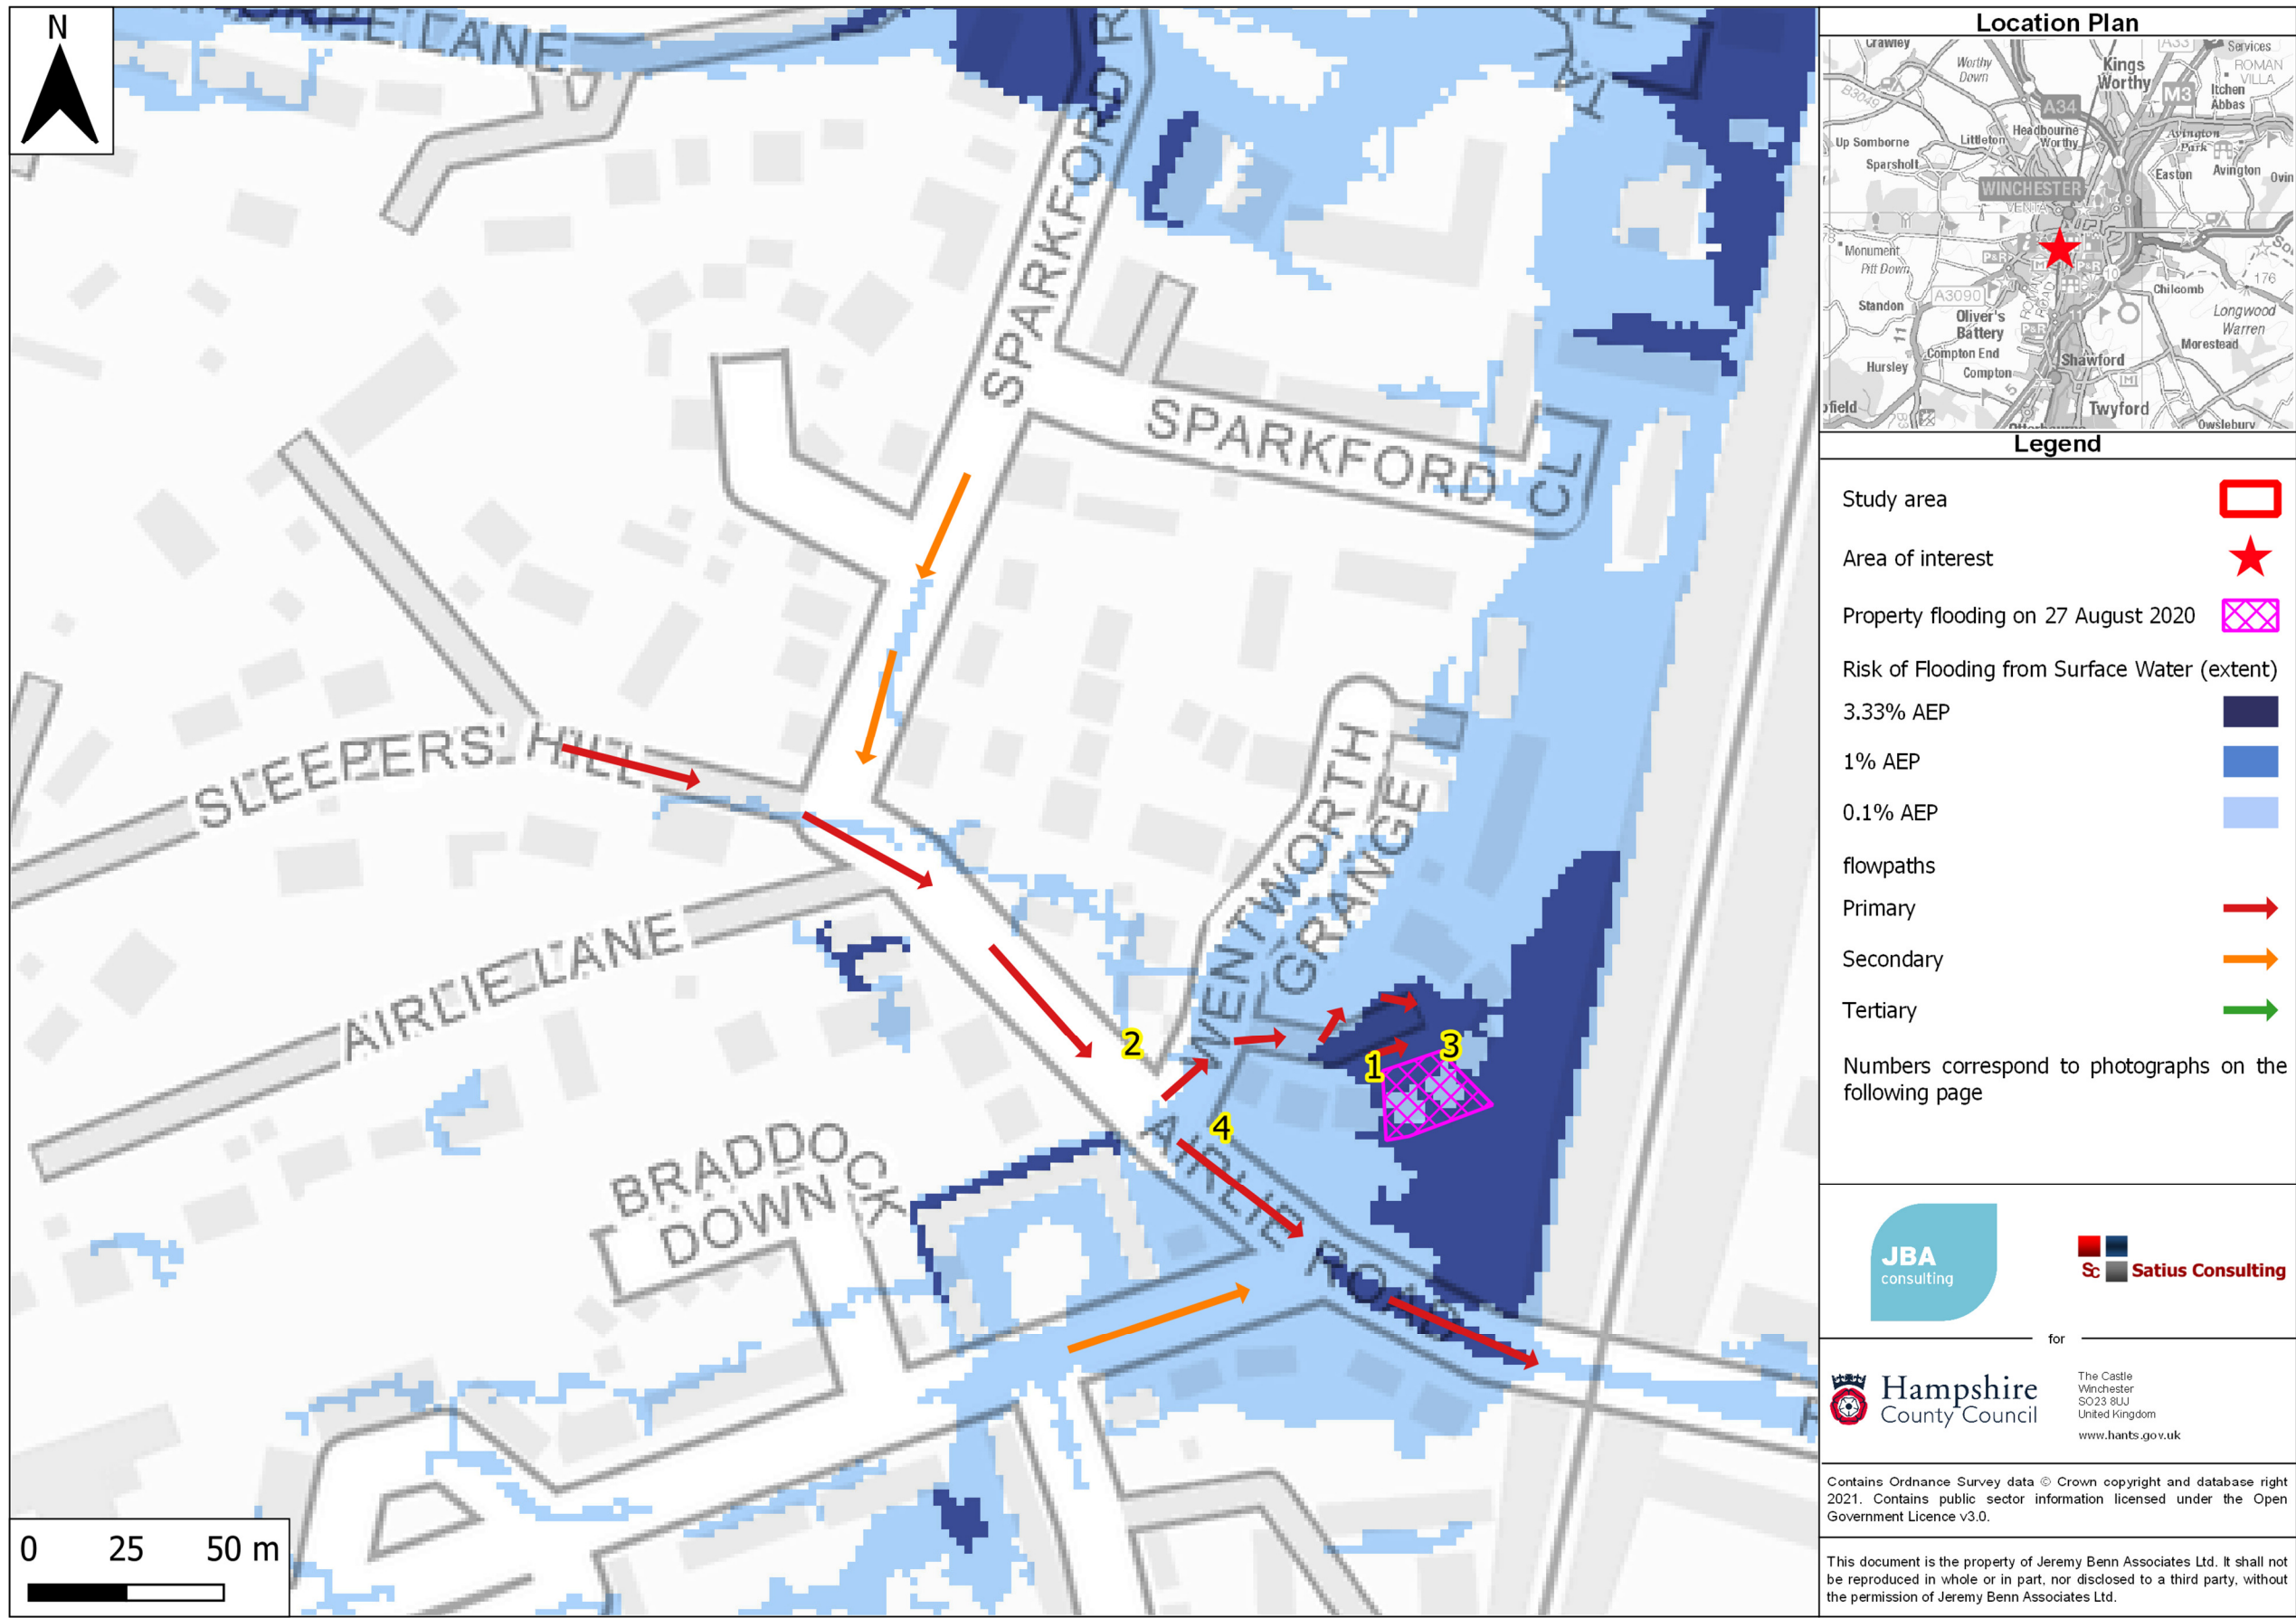
Figure 6-8: Source-Pathway-Receptor mapping for Wentworth Grange and Sleepers Hill on 27 August

Surface water runoff flowed from Sleepers Hill and Sparkford Road which are at a higher elevation (approximately 49m AOD) in comparison to Wentworth Grange (approximately 41m AOD). This runoff converged at the junction with Airlie Road before flowing down slope towards the railway bridge. Large volumes of surface water runoff also flowed into Wentworth Grange (location 2 and 4 in Figure 6-8 and Figure 6-9) due to the camber of the road, this runoff pooled in the cul-de-sac (location 1 in Figure 6-8 and Figure 6-9) where it rose, to depths of approximately 200mm in Wentworth Grange.

At least one property in Wentworth Grange experienced flooding, although this was mostly limited to the highway, driveways and the gardens of the dwellings with surface water surrounding a number of properties to a depth of approximately 80mm (location 3 in Figure 6-8 and Figure 6-9). The responses also note that several properties were close to flooding internally with water within the curtilage and close to reaching the property thresholds.

Responses to the stakeholder engagement survey indicated that there may be inadequate or insufficient drainage along Sleepers Hill that may have contributed to this although it should be noted that these areas are at a significantly higher elevation than Wentworth Grange. It was also noted that the drains appeared to cope with the water at first, before being overwhelmed.
