# Winchester Section 19 Investigation

## Final Report

June 2021

**Hampshire**  
County Council

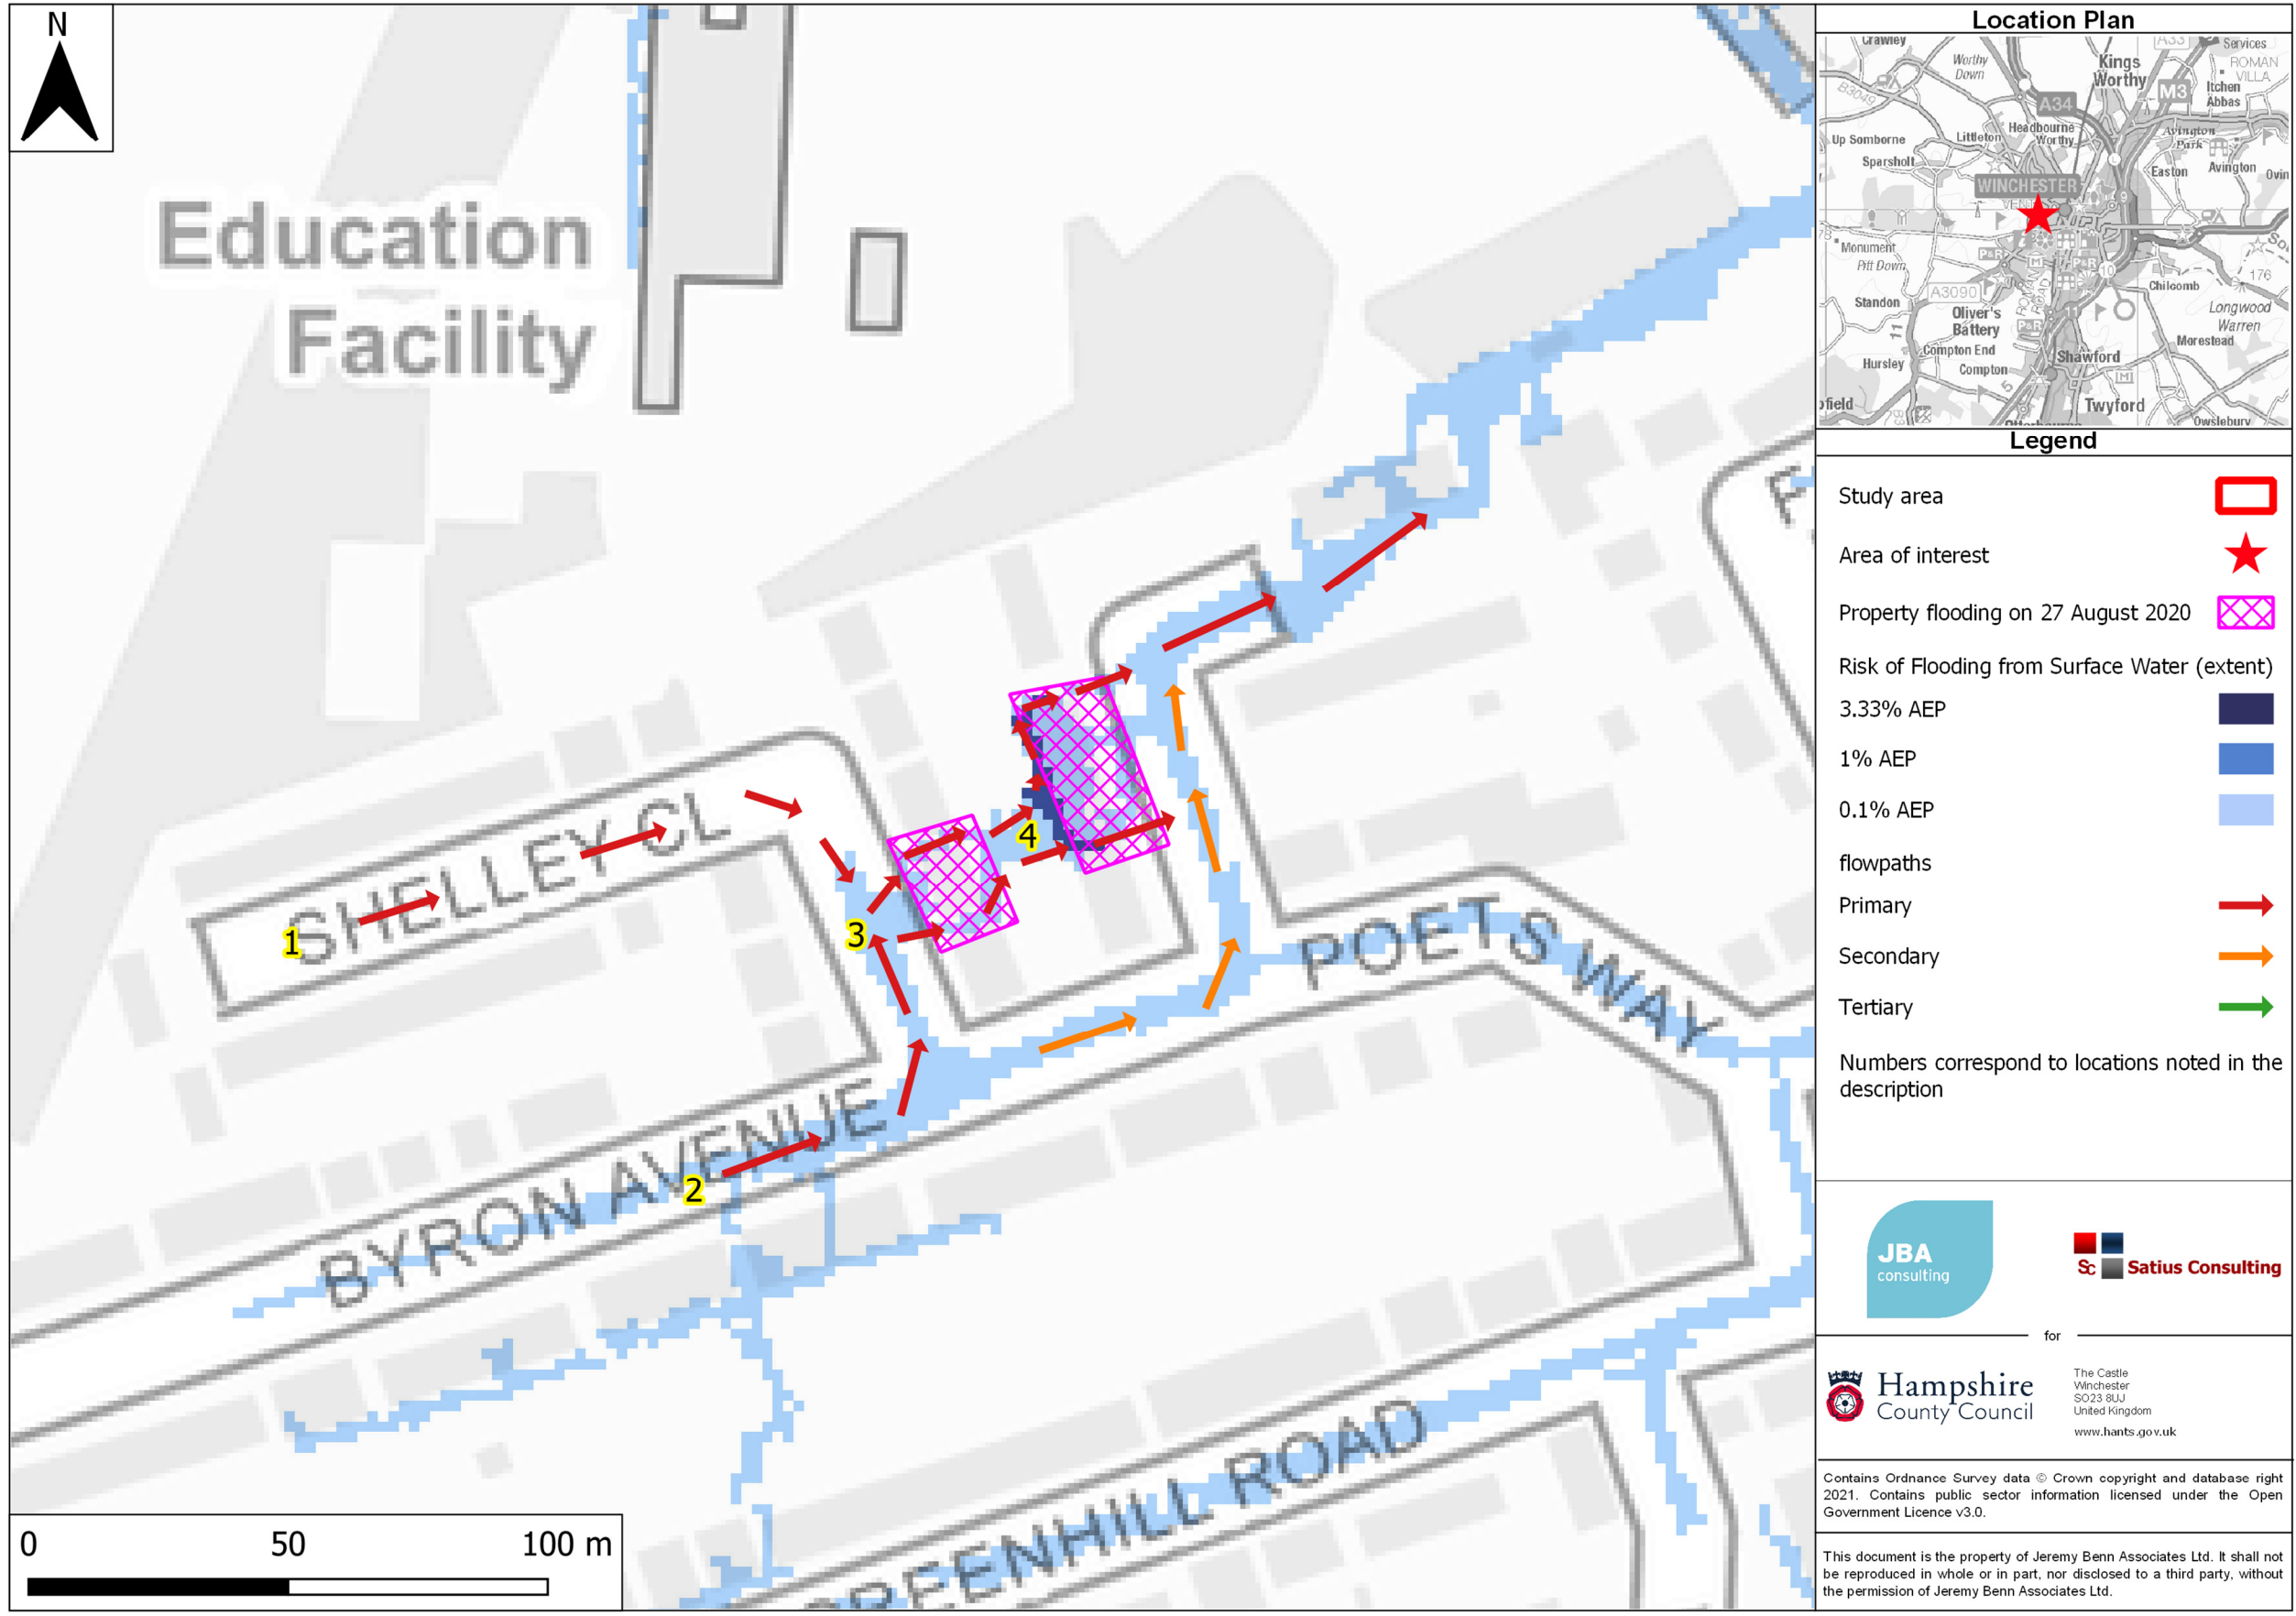
Figure 6-10: Source-Pathway-Receptor mapping at Browning Drive and Wordsworth Close on 27 August

The stakeholder engagement surveys indicate that surface water runoff originated from the surrounding roads, including Shelley Close (location 1 in Figure 6-10) and Byron Avenue (location 2 in Figure 6-10), this runoff flowed to the lowest point in the area at the centre of Browning Drive where survey responses indicated that the highway drains were unable to cope with the volume of water. Water continued to pool in the centre of Browning Drive before overtopping the kerb, causing internal flooding to at least one property on Browning Drive (location 3 in Figure 6-10). Surface water cascaded down the side of these properties into the rear gardens of properties in Wordsworth Close (location 4 in Figure 6-10), before flowing out onto Wordsworth Close.

This flooding has led to one resident having to temporarily move out and has caused damage to carpets and flooring. In at least two cases, action by residents to bail water out of driveways and clear private soakaways prevented additional internal property flooding. Residents have also bought sandbags in an attempt to mitigate future flooding.

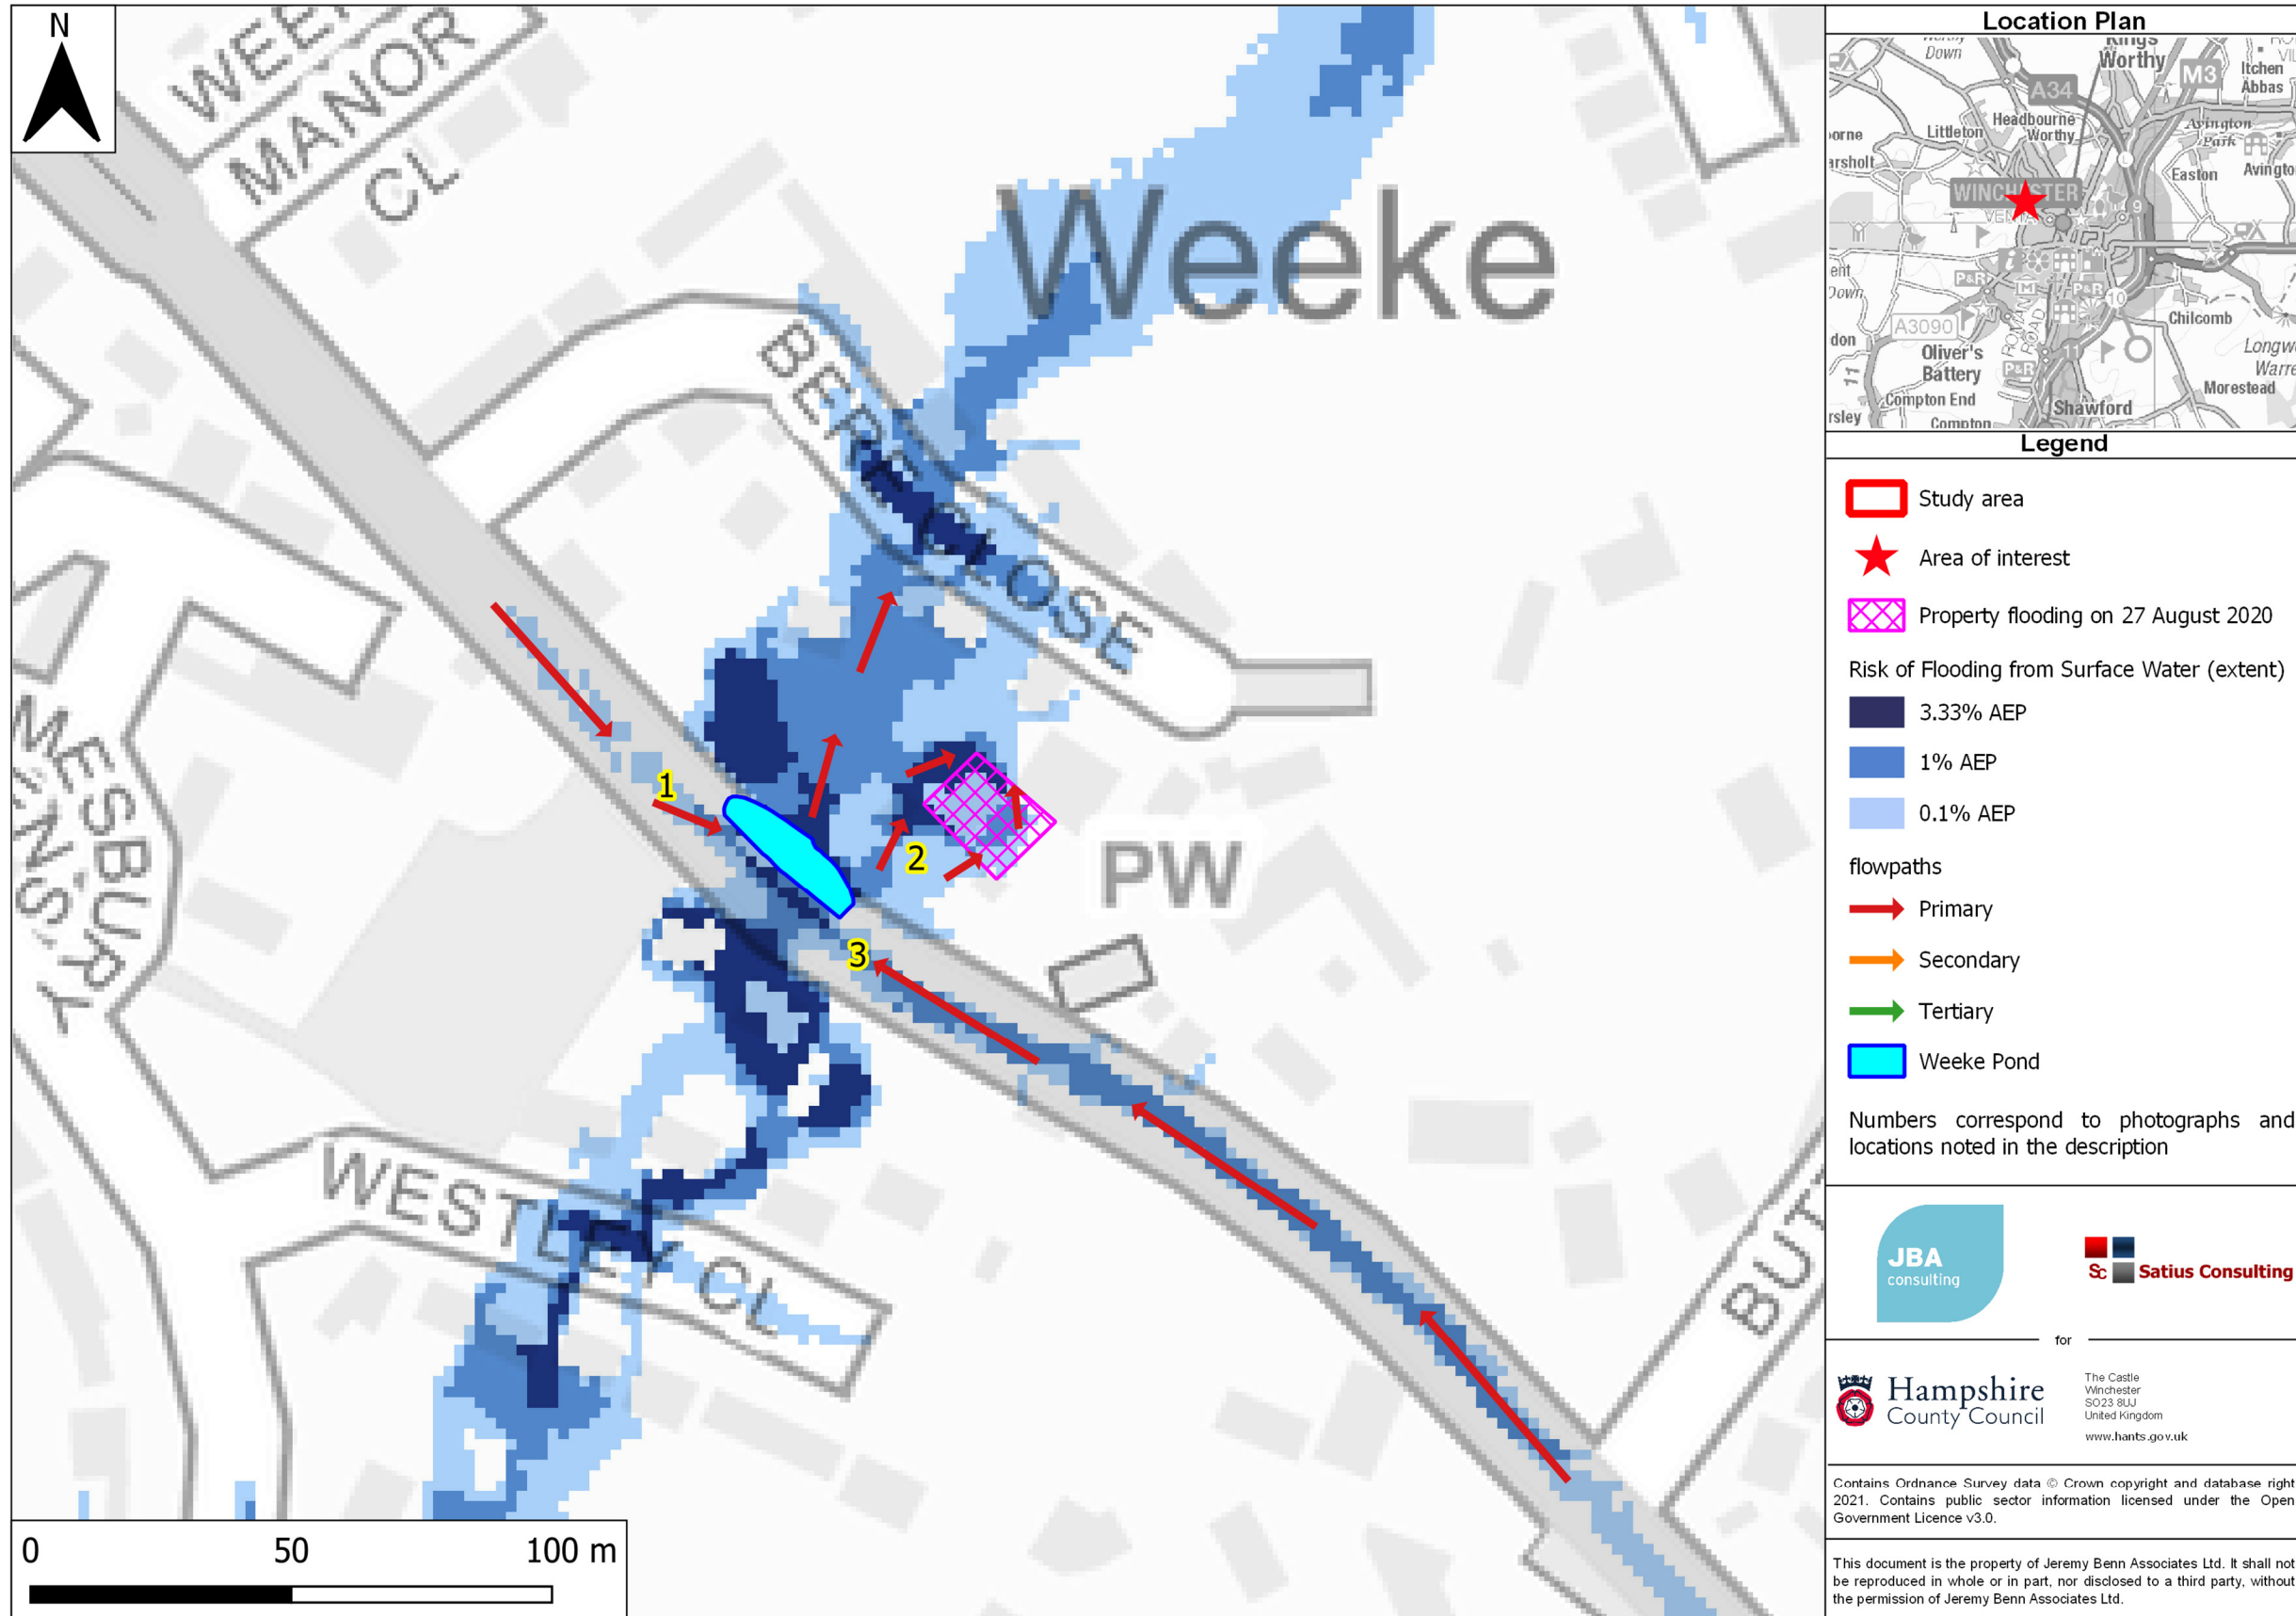
Figure 6-12: Source-Pathway-Receptor mapping for Weeke Pond, Stockbridge Road

Stockbridge Road has a significant gradient and this would have led to the generation of large volumes of surface water runoff during the event on 27 August. Furthermore, the Risk of Flooding from Surface Water mapping indicate that additional flows could have originated from Westley Close in the South. As there is connectivity between the highway drainage and the pond, it is likely that water levels in the pond would have risen rapidly with these flows exceeding the outflow capacity of the pond and led to overtopping. Stockbridge Road up to Butts Close south of the pond are also at a higher elevation than the pond, this would have resulted in additional surface water flows pooling in the pond. (location 3 in Figure 6-12)

Once flows overtopped the pond, this led to flooding of Stockbridge Road (Figure 6-11 and location 1 in Figure 6-12) which would have flowed downslope towards Cranworth Road. The highway drainage in this location would also have become surcharged, preventing any additional flows from being drained. The pond is at a higher elevation than houses on the north side of the road, flows from the pond followed the topography through the garden of the property before causing internal flooding (location 2 in Figure 6-12).

A number of other properties are also known to have flooded along Stockbridge Road or adjoining roads, including properties along Western Road and Dean Lane. These properties are all within surface water flood extents as predicted by the Risk of Flooding from Surface Water mapping.
