Cabin Boatyard

Repair of Quay wall

*Design and Access Statement
inc Method Statement and FRA*

*Feb 2013
10236 DAv1*

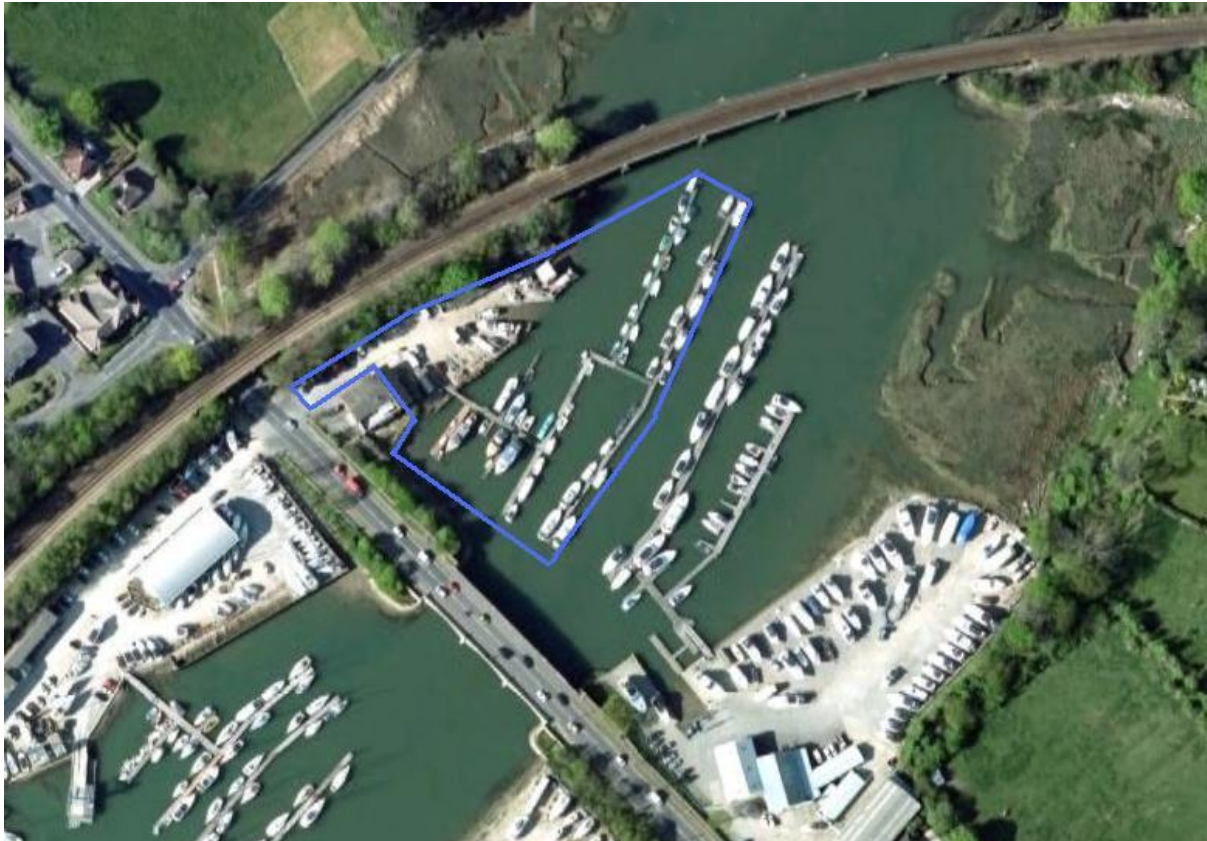
The picture below shows the boatyard with the area of ownership (inc lease) shown in blue.

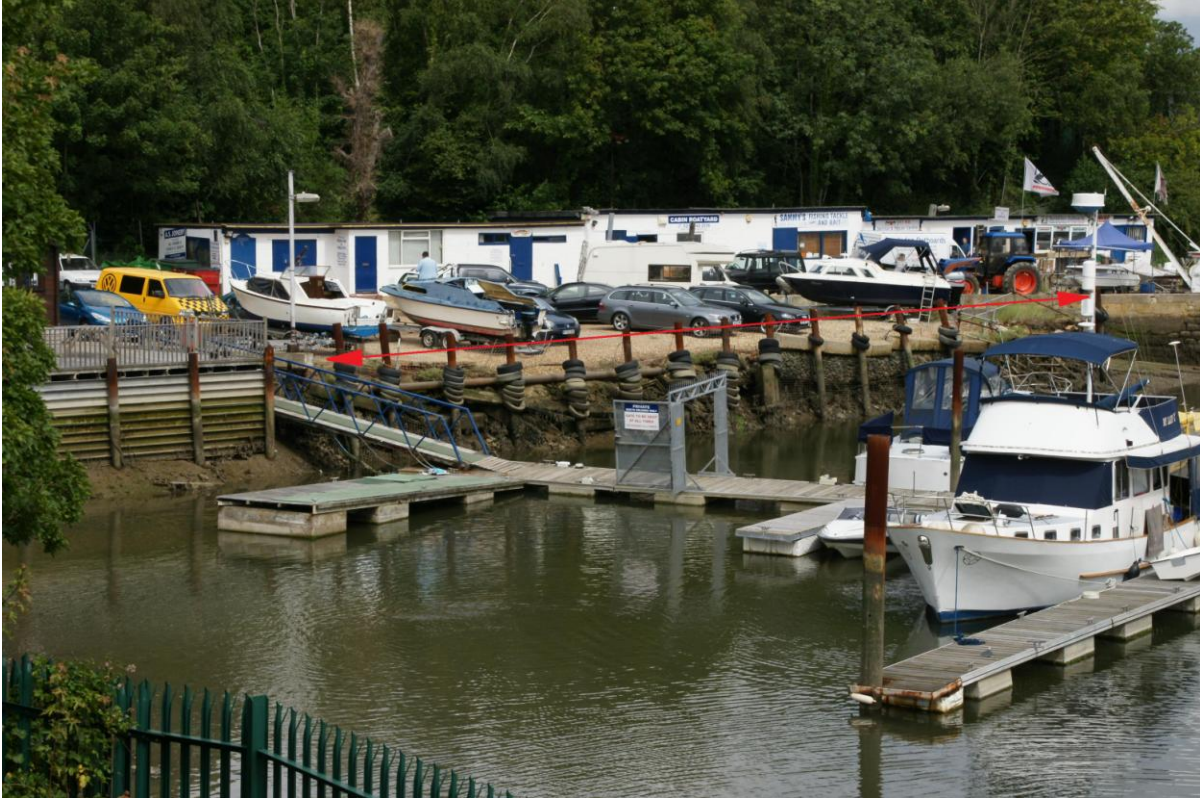
The picture below shows the current state of the wall with the red line indicating the length of the proposed new wall.

The existing boundary between the land and the water (the quay wall) consists of tubular steel piles with some infill. This is in an unacceptably poor condition and requires major repairs or replacement.
