NAVIGATIONAL RISK ASSESSMENT

ROYAL SOUTHERN YACHT CLUB

ROYAL AIR FORCE YACHT CLUB

Project Ref No:	MP189	
	Name	Date
Prepared by:	Simon Goodhead & Dan McKiernan	03/09/2012
Approved by:	Mike Ward	07/09/2012

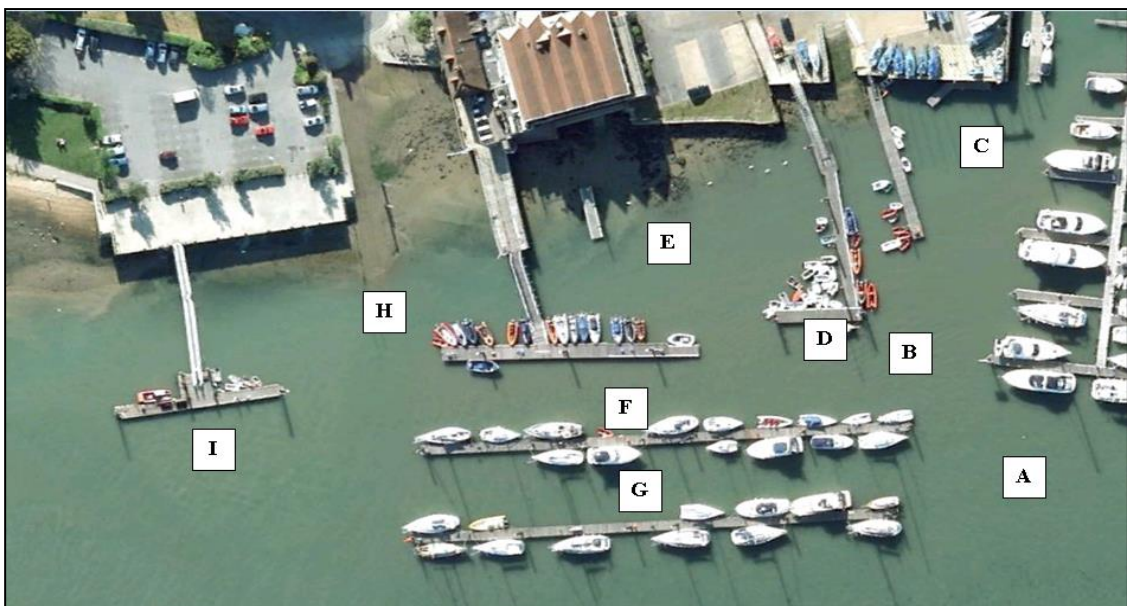
Figure 7.2 Key Points of Activity and Assessment

The existing configuration is broken down into distinct areas of assessment brought about by the navigation of vessels in and around the facility. The areas of assessment are illustrated in Figure 7.2 and 7.3. For consistency the proposed layout utilises the same assessment method in order that areas of navigational review may be compared on a before and after development basis.

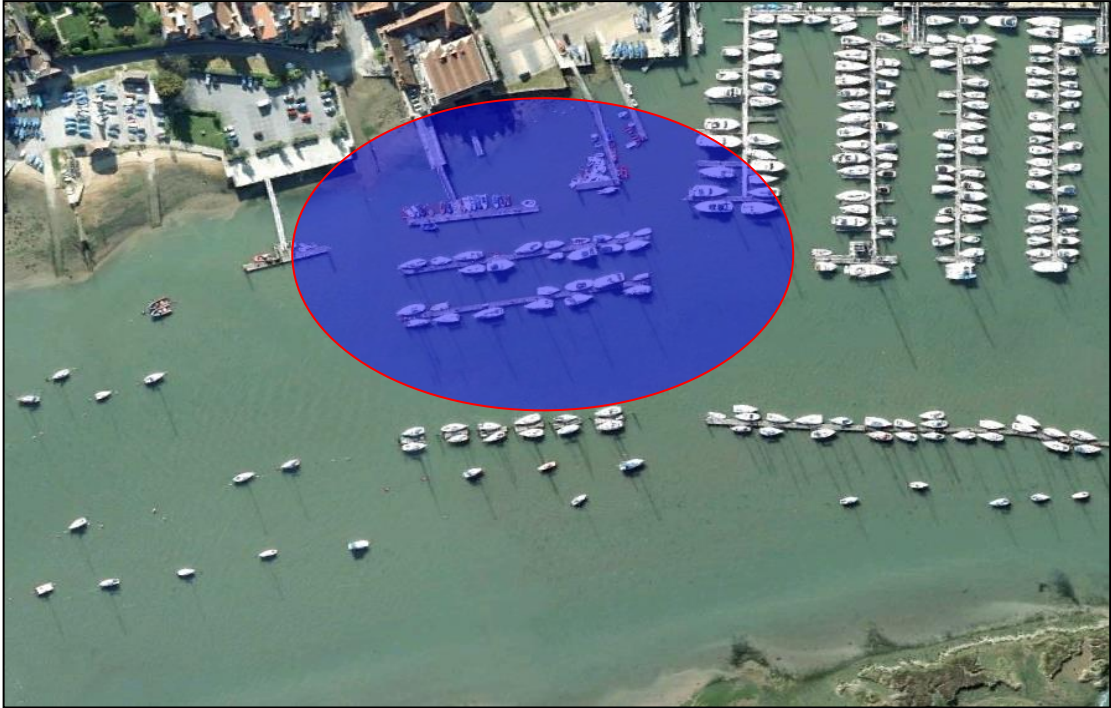
Figure 7.3 Key Points of Activity and Assessment Across River

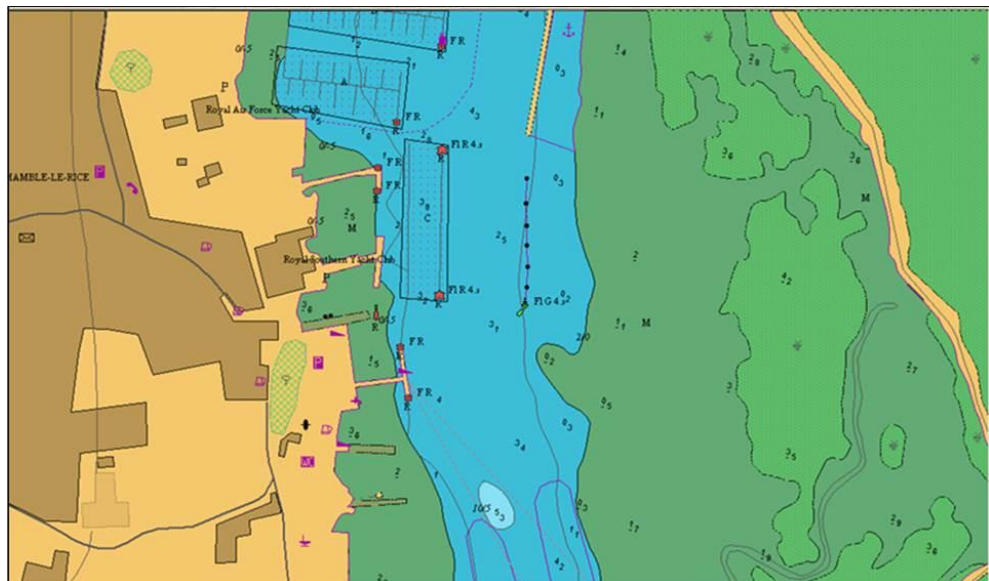
The position of the lights opposite the RSrnYC is identified in Figure 7.4 which in turn confirms clearly the location of the Main Navigation Channel.

Figure 7.4 – Location of Navigation Marks

Historic correspondence between the RHHA and Trinity House from December 1999 confirms the approval of Trinity House to extinguish navigation lights previously fixed to the RSrnYC walk-ashore pontoons and establish two new lights at either end of the outer RSrnYC pontoons. The point is made in this correspondence that the outer pontoons are inshore of the navigation channel. The relevant correspondence is provided at Appendix 4.

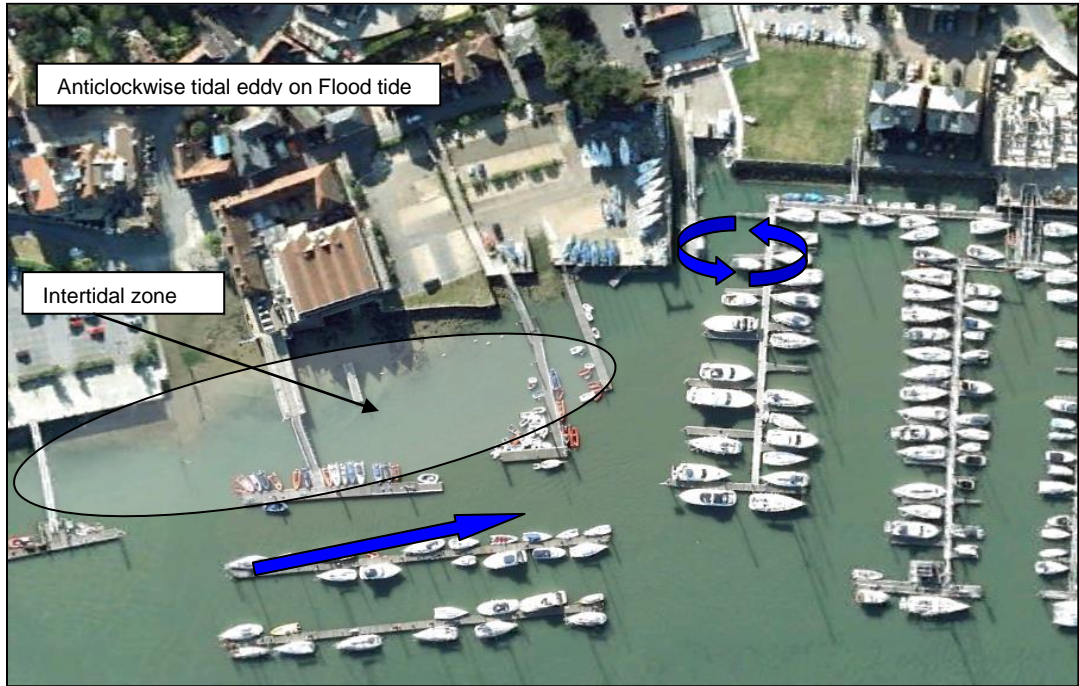
Figure 7.5 Flood Tidal Flows & Resultant Anticlockwise Eddy

- Multiple users of a restricted water area
- Unpredictable flood and ebb tidal flows as illustrated in Figure 7.5 and 7.6 from mid to low tide (due to the influence of the intertidal mudflat to west)
- Large vessels of up to 18.5m l.o.a. manoeuvring in a confined water area
- Unsighted vessels making passage between the inner moorings
- Sailing vessels without auxiliary engine power being towed through this area
- Multiple users with no single management/control of the water area, the area is somewhat self-regulating and it is the responsibility of the each vessels skipper to ensure safety of navigation
- As the facility is utilised at times by visitors with no prior experience of the water area, tidal flows or prevailing conditions

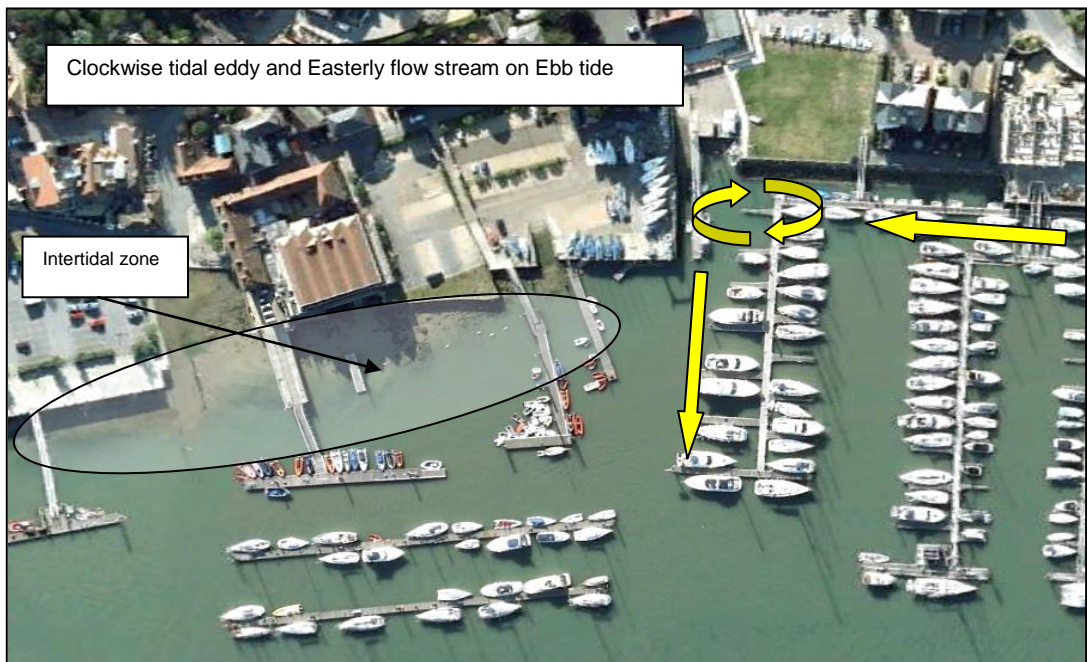
Figure 7.6 Ebb Tidal Flows & Resultant Clockwise Eddy & Easterly Flow Stream

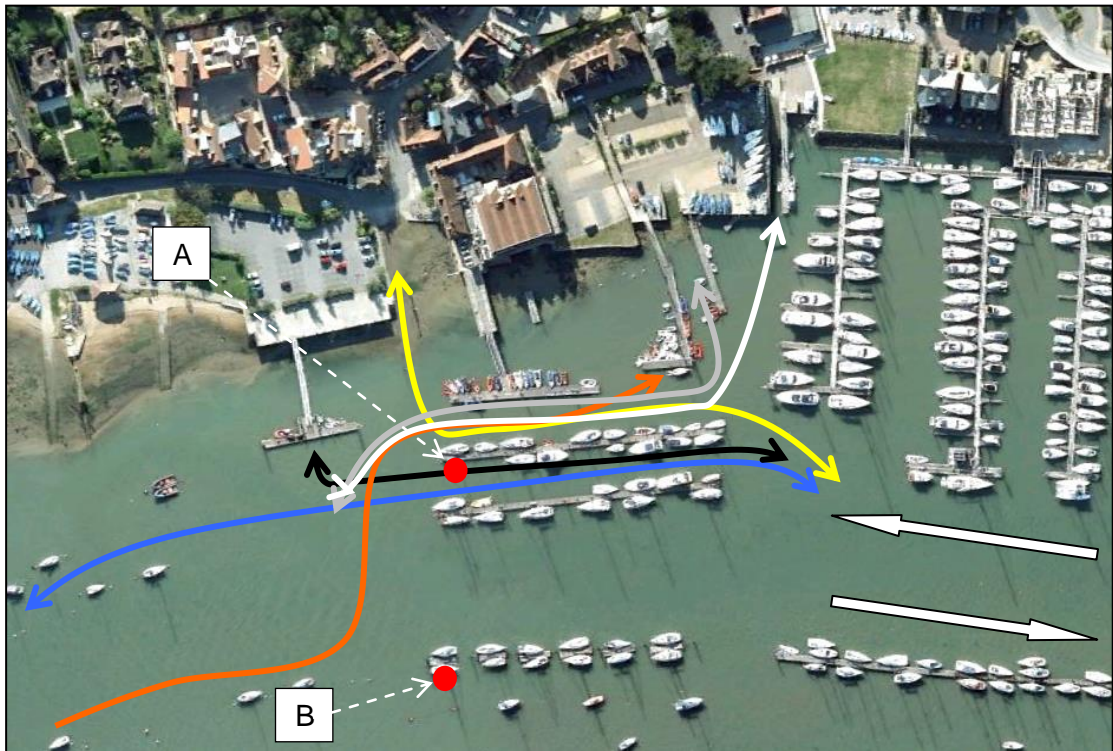
A number of typical existing passages through the mid-stream moorings are illustrated in Figure 7.7.

Figure 7.7 Typical existing mid-stream mooring routes of navigation

It is to be noted that upstream passage through the mid-stream moorings and along the west of the main navigation channel results in vessels entering the main channel on the starboard side of vessels headed downstream. This is against safe navigational protocol (vessels must pass Port to Port), COLREGs and the Harbour Master’s Direction No.2. These vessels also emerge into the main channel immediately adjacent to the busy Port Hamble Fuel Berth.

Tidal flow rates have been recorded at the study site by specialist ABPmer. At point 'A' referenced in figure 7.7 peak flow rates during the flood tide are 0.35m/s or 0.68 of a knot. At point 'B' across the river peak flow rates during the flood tide are 0.52m/s or 1.01 knots. Whilst flow rates are greater in the main channel the 0.33 knot difference is slight and would be almost undetectable for a vessel that was making headway downstream against the flood tide flow. In addition the difference in flow rates between point 'A' and the west side of the main channel (used by vessels heading downstream) are probably less than 0.33 of a knot as this point is only some 20m to the east of point 'A'. It is to be noted that peak flow rates further upstream in the main channel opposite the location of Hamble Yacht Services are recorded as being 0.9m/s or 1.75 knots. Vessels making passage downstream in the main navigation channel from this point are already exposed to tidal flow rates far greater than that experienced at points 'A' or 'B'.

- The Maximum flow rate recorded at the south end of the inner mid-stream pontoon (Point A figure 7.7) over a Spring Ebb tide of 3.5m range is less than 0.4 metres per second or 0.77 knots.
- As a direct consequence of the capital dredge and the removal of the intertidal mud flat directly affronting the RSnYC, the cross-sectional area of the river is increased at this point. This increased cross-sectional area amounts to 114m².

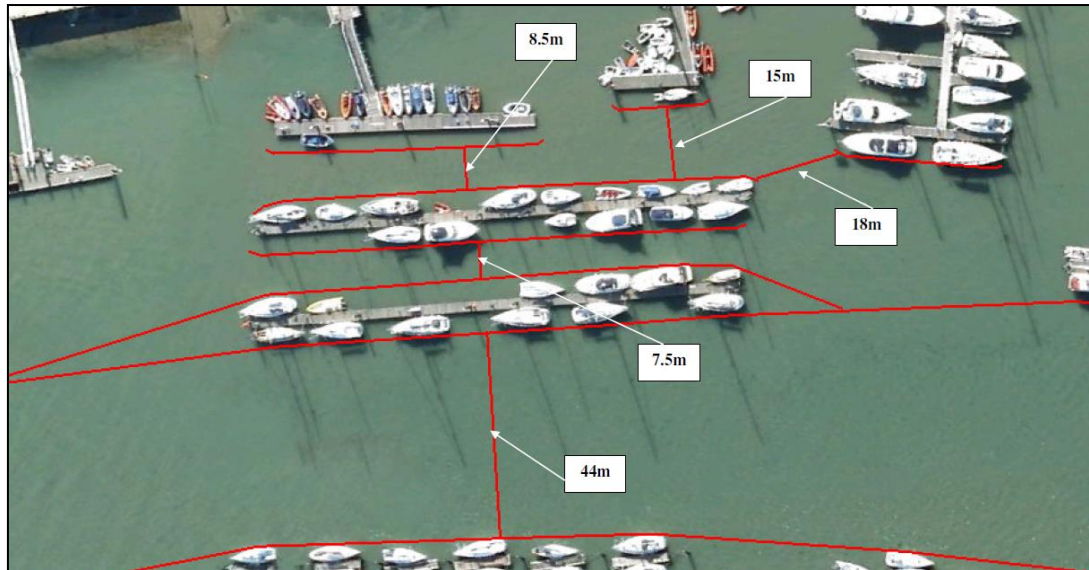
The clear water areas are illustrated in Figure 7.8

Figure 7.8 Indicative Inner Mooring Clear Widths

The widths between the mooring zones of between 7.5m and 8.5m do not comply with industry standards for an inner channel of navigation as outlined in TYHA guidelines for marinas as noted overleaf:

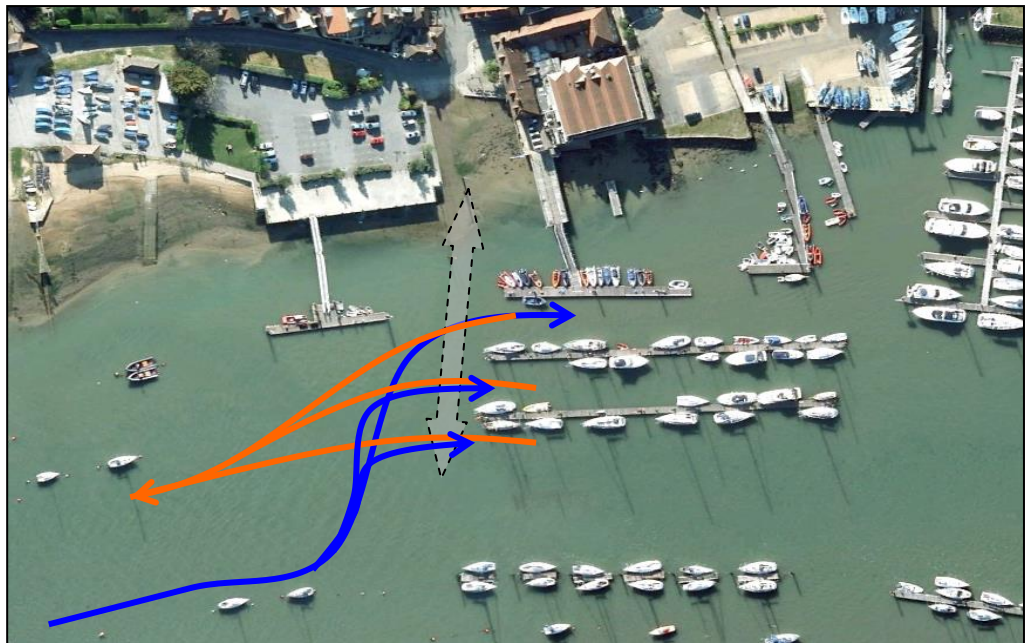
Figure 7.8 Cross flow activities to and from Hamble Slipway facility

- Personal water craft (i.e. kayak, canoe, inflatable dinghy etc.)
- Trailer boats/vessels capable of being launched on a tidal slipway
- Vessels utilising the inspection piles
- The facility is not widely utilised by members of RAFYC, Port Hamble Marina or RSnYC and therefore there is little evidence of activity from the slipway through the mooring zone to a berth or facility. It is to be noted however that vessels travelling upstream to the mooring zones within the study site or downstream from moorings within the study site, may pass through this water area across the path of vessels heading to or from the Hamble Slipway facility as illustrated in Figure 7.8.
