Timsbury Bridge - concrete repair

Timsbury Bridge is an early two span reinforced concrete bridge, built circa 1910, carrying the A3057 Stockbridge Road over the River Test. Inspection showed the concrete deck exhibited spalling of concrete due to severe corrosion of reinforcement. Subsequent assessment proved weakening of some structural elements.

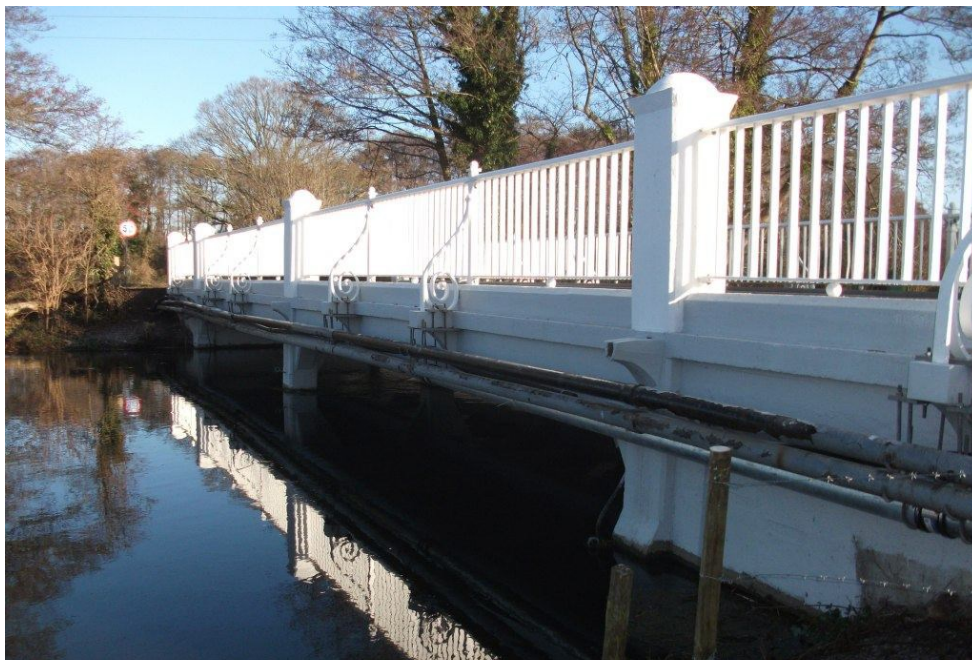
Our brief was to identify the cause of corrosion, carry out remedial works, and strengthen the bridge. Close inspection and testing proved that the low concrete cover to reinforcement and high levels of chloride in concrete were the causes of corrosion.

After considering several options, the solution of concrete repairs with installation of galvanic anodes to prevent corrosion through the bridge deck was adopted. We also installed carbon fibre reinforced plates to main beams where original shear links had corroded away, applied a protective concrete coating to the whole structure and repainted the parapets.
